Articulated truck rollovers (update)

Mines safety bulletin no. 170

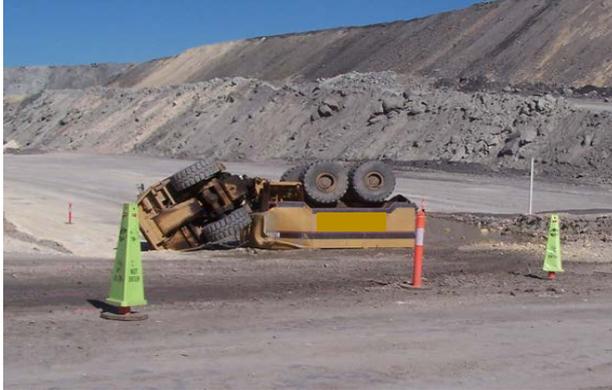
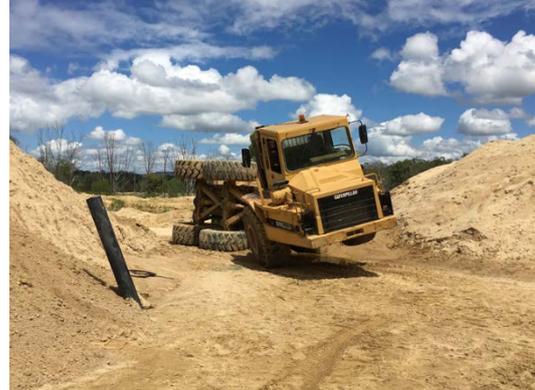
On average, an articulated dump truck / water truck rollover occurs every 2 months and of the 64 incidents reported since 2006:

- 37% occurred whilst vehicles were reversing—riding up over uneven ground or stockpiles.
- 35% occurred whilst vehicles were turning—speed, downhill, reverse cambers and wet surfaces.
- 22% occurred whilst vehicles were travelling—operator loss of control.
- 6% occurred on sloping ground.

While the truck cabin remained upright in 92% of the rollover incidents, machine operators have sustained injuries (some serious) in 6% of these incidents.

The continuation of these rollover events at quarries and mines is evidence that the risk controls for operating articulated trucks are both inadequate and ineffective at an industry level.

Site senior executives must ensure risk assessments are developed specific to **the operation of articulated vehicles**. Effective controls that are identified during the risk assessment process must be implemented and maintained. Such risk assessments should consider the OEM recommendations and include the following factors as a minimum:

- Requirements for training and competency of operators, and supervisors
- Mandatory wearing of seat belts
- Roadway and circuit design criteria, such as curves, cambers, road surface, watering procedures
- Operational limitations eg speed/gear restrictions, maximum grades/slopes etc
- Distribution of load evenly in the body to avoid raising the centre of gravity
- Dump area design and dump procedures.
