## Week ending 18 April 2018

This incident summary provides information on reportable incidents and safety advice for the NSW mining industry. To report an incident to the NSW Resources Regulator: phone 1300 814 609 24 hours a day, 7 days a week.

ISR 18-15

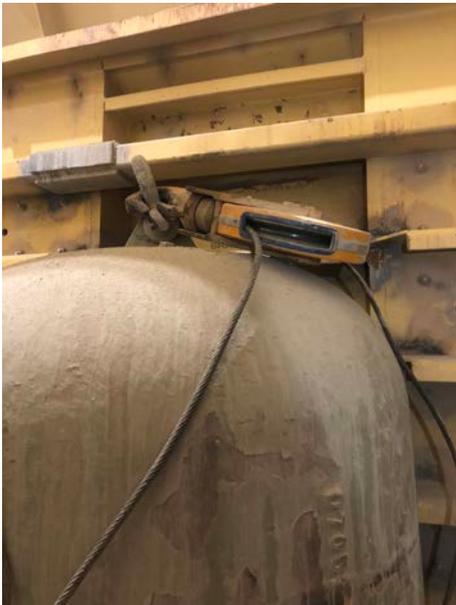
Incident type	Summary	Recommendations to industry
Dangerous incident SinNot-2018/00580	<p>While lifting a 4-tonne spider cap on a primary crusher, a 10-tonne overhead crane hoist rope failed.</p>

<p>Lifting procedures must include checks of safety devices fitted to cranes.</p> <p>Workers must follow a site standard or procedure detailing all requirements for bridging, forcing and system impairment including communication to other parties.</p> <p>For routine tasks, procedures should include details of the crane position to achieve a safe lift.</p>
Dangerous incident SinNot-2018/00563	<p>A collision occurred between two haul trucks. One truck reversed into the other. There were no injuries but one truck was damaged.</p>	<p>Mines should review Safety Bulletin <a href="#">SB18-06 Lack of positive communications</a></p>

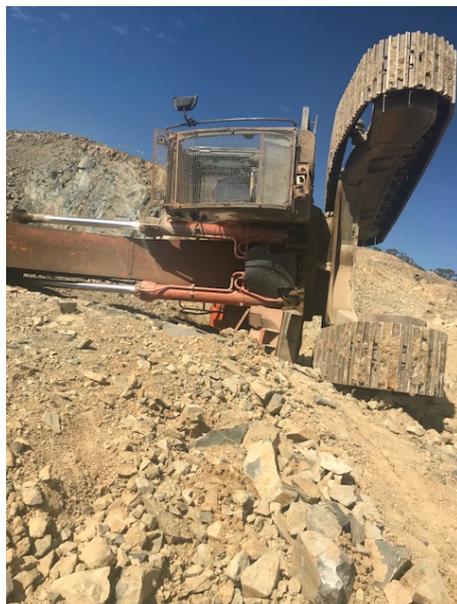
Dangerous incident  
SinNot-2018/00555

An excavator rolled onto its side while clearing overburden on a bench. The operator suffered minor injuries requiring first aid treatment. The operator was wearing his seatbelt, which reduced the severity of his injuries.

Equipment operators must remain vigilant of the risk of machine roll overs and should be reminded of the importance of wearing seatbelts.

When planning tasks and travel paths, supervisors must consider roll over hazards.

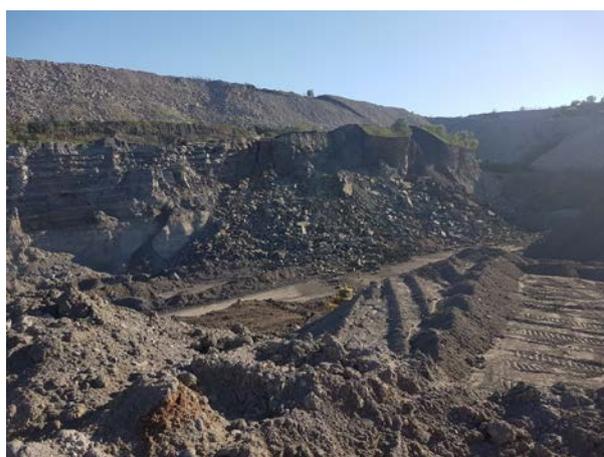
Dangerous incident  
SinNot-2018/00554

A highwall failed and material spilled over the bund protection and onto the working bench below. This blocked access to part of the pit.

While no workers were present in the area where the failure occurred at the time and no equipment was damaged, three workers were temporarily unable to egress the pit due to the access ramp being damaged when the highwall failed.

Review the frequency of assessments of highwall stability and confirm appropriate triggers are included to increase frequency of assessments arising from events such as rain events and shot firing.

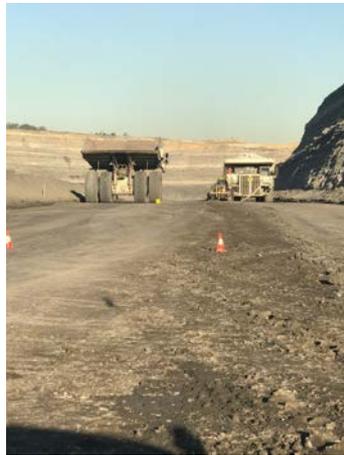
Dangerous incident  
SinNot-2018/00553

A haul truck ran into a grader while trying to pass it. Positive communications protocols were not followed. No injuries were reported

but heavy damage was caused to each machine, including a burst tyre.

Review the recommendations for positive communications in [Safety Bulletin SB18-06](#).
