Significant Incident Report No. 265

Subject: Manned loader falling into an open stope

Date: 03 August 2018

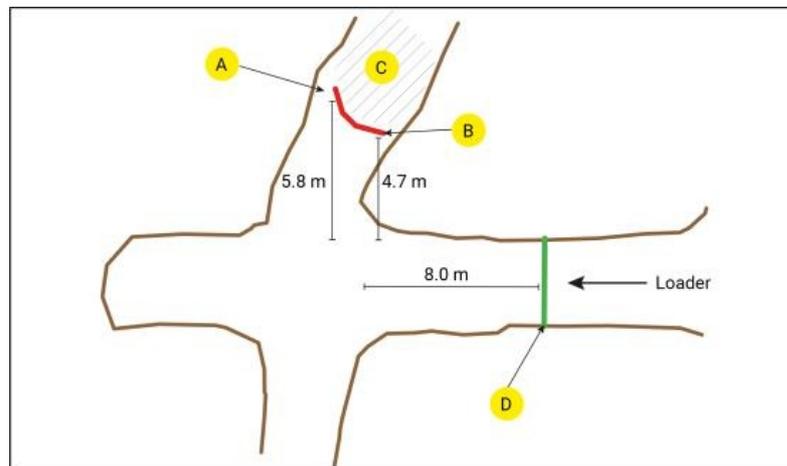
As the operator was tipping the load, the right hand side of the loader slumped and the operator exited the loader via the cab door. The loader kept moving forward under its own power and fell over the crest into the stope, coming to rest on the rill of ore below. The operator was uninjured.

Level plan showing the direction the loader was travelling, as well as the brow pick-up (A), the edge of the open stope (B), the void (C) and the location of the restricted access sign (D) in the drive.

- Lack of adequate controls to manage the risks for mining activities near a void.

- No visual markers on the wall for the operator to position the bund safely.
- Reduced operator visibility:
 - the edge to an open stope was located on a bend
 - the loader was still articulated at the point of tipping (poor operator visibility)
 - there was limited lighting.
- The operator misjudged the location of the edge leading into the void.

- perform a formal team-based risk assessment to identify hazards and control measures before any work is commenced in the vicinity of an open stope or any other void. This should be in addition to lower level risk assessments (e.g. field level risk assessments, Task Hazard Analysis)
- install physical hard barriers in conjunction with lower level access controls (e.g. signage, demarcation). Hard barriers prevent workers and equipment accessing the edges of voids and should be:
 - designed and constructed at appropriate locations before open stopes or voids
 - where practicable, installed *before* creating a void
- use markers or spotters for or during the construction of bunds when safe to do so.
