INCIDENT ALERT

LOCATION:	ON-HIGHWAY	ALERT STATUS:	Normal
ACTIVITY:	TRANSPORT / DELIVERY	DATE ISSUED:	24/07/2019 14:21:53
SUB ACTIVITY:	LOADING	INCIDENT No:	01519

Fatal 6 - Serious road traffic accident involving volumetric vehicle overturning

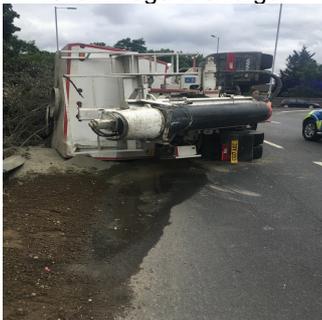
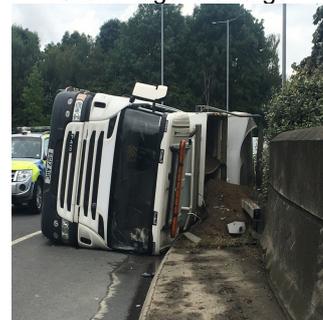
The driver slowed down as he approached a roundabout in the first lane, as he entered the roundabout, he accelerated to continue on the main road at the second exit. As the vehicle passed the 1st exit and continued to steer around the roundabout, the rear right wheels lifted. This action made the chassis flex and caused the metro flow tank at the rear of the vehicle to lean. This caused the load to shift which resulted in the vehicle toppling over. The vehicle fell onto the passenger side. No other vehicles were involved.

- Provide an Incident Notification
- Lessons Learned document will be produced within 14 days
- Ensure loads on volumetric vehicles are evenly distributed
- Ensure that the gross weight is recorded before exiting sites
- Request and review all footage and documentation
- Investigation into incident by SHEQ Manager in conjunction with Transport Supervisor
- Interview driver
- Request information from Police (CAD number recorded at scene)

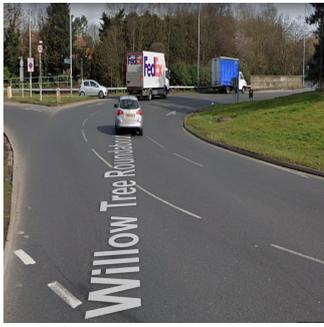
The image below shows the road where the accident occurred, the blue van marks the position where the vehicle overturned.

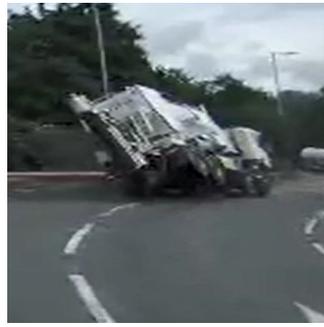
A camera captured an image prior to the truck toppling over.

Camera image of vehicle overturning
