Dangerous incident

- **Incident date:** 17 May 2017
- **Event:** Dangerous incident during blasting at open cut coal mine
- **Location:** Moolarben Mine, Ulan NSW

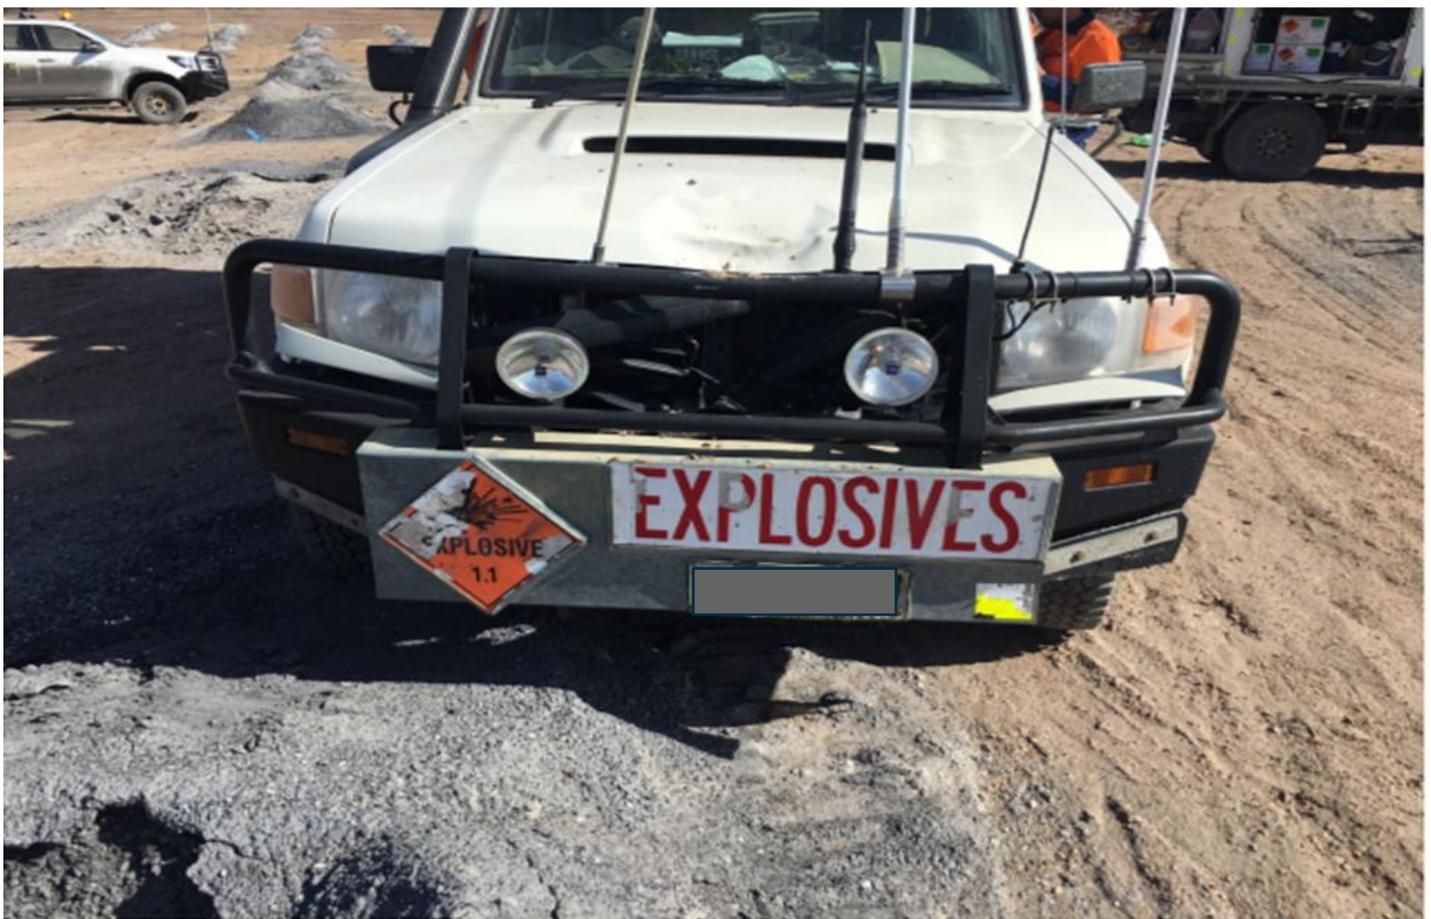
Photograph 1: Damage to bonnet and front grill of light vehicle caused by flyrock.

As the flyrock began falling to the ground some of the workers took cover while others attempted to visually observe, track, evade and warn others of the flight path of the flyrock. Flyrock landed and struck one of the nearby light vehicles damaging the bonnet and front grill. No workers were struck by the flyrock. After the flyrock fell to the ground the workers relocated themselves and the vehicles from the immediate area due to dust and fumes produced by the blast.

Early information suggests the flyrock was ejected from a single shot hole. The most likely cause was under-stemming, potentially caused by bridging of the stemming, but other potential causes will be examined during the investigation.

Mine operators must ensure that appropriate information, instruction and supervision is provided to workers in relation to exclusion zone requirements prescribed within the mine's explosives control plan.

Mine operators are reminded that appropriate systems must be in place to review and audit the explosives control plan and blasting work practices to ensure that exclusion zone requirements are enforced.
