Reference Number	Bulletin 01 – 2019*
Affected Product	Potential failure of large motor grader front wheel spindles
Risks Identified	Failure to apply the recommendations in this Equipment Safety Bulletin may increase the risk of spindle failure
Release Date	18 January 2019

**This bulletin replaces Bulletin 013 2013 which has been cancelled*

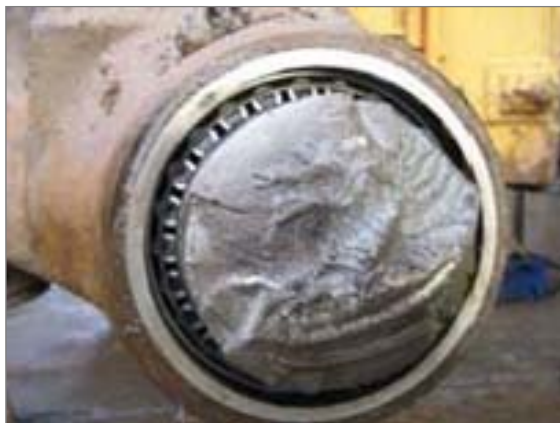
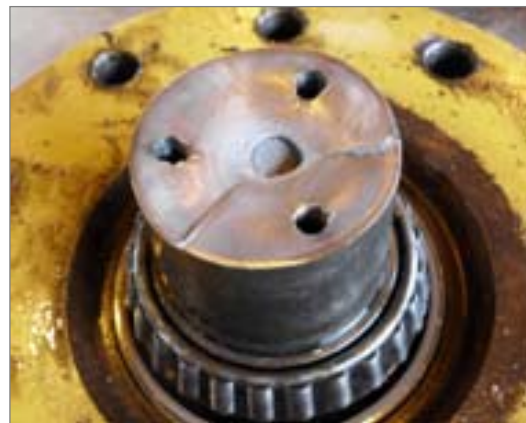
Fractures have occurred in front wheel spindles on Large Motor Graders used in mining applications. The images below demonstrate damage from the two failure modes observed.

Front wheel spindle fractures have occurred at the base of the spindle behind the outer tapered roller bearing, and near the bottom of the retainer bolt holes. Current part number spindles have a radius at bottom of bolt holes and an improved hardening process to make the spindle more durable.

At 12,000 spindle hours or first life overhaul, remove and inspect the front wheel spindles. Perform visual inspection and 100% magnetic particle examination of the spindle. Also perform ultrasonic testing in the area around the retaining bolt holes. Do not reuse spindles that have crack indications at any location.

Immediately remove machines from service that have crack indications in the locations identified in Special Instruction M0068684*. Discard the front wheel spindle and replace with new, using the latest part available. Replace any other damaged parts. Operation of a machine with a cracked spindle can lead to catastrophic failure and result in property damage and injury.
