INCIDENT ALERT

ALERT STATUS: **Critical**
DATE ISSUED: 11/02/2018 20:38:32
INCIDENT No: 01483

Tyre rim wear

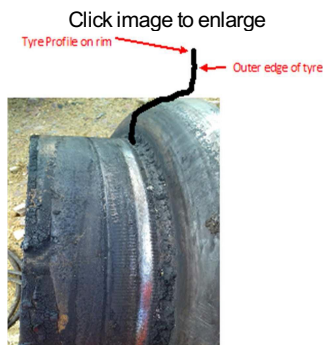
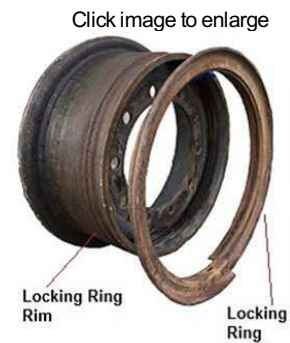
The result of the investigations found that the rim was worn causing air to escape and the tyre to be under inflated. The resulting damage, which provided insufficient grip to the tyre and under inflation, allowed the tyre to move on the rim creating heat that lead to the blow out.

The image shows a silver band on the rim that has been caused by the tyre moving on the rim. The area should be a serated band to help grip the tyre

- Any unexpected loss of tyre pressure during regular checks should be reported.
- Ensure tyre companies inspect the rims for damage when fitting new tyres.
- Tyre blow-outs can be fatal and all repairs must be carried out by a competent company.
