Week ending 22 February 2019

This incident summary provides information on reportable incidents and safety advice for the NSW mining industry. To report an incident to the NSW Resources Regulator: phone 1300 814 609 24 hours a day, 7 days a week.

CM9 reference	DOC19/172635
Mine safety reference	ISR 19-08
Date published	4 March 2019

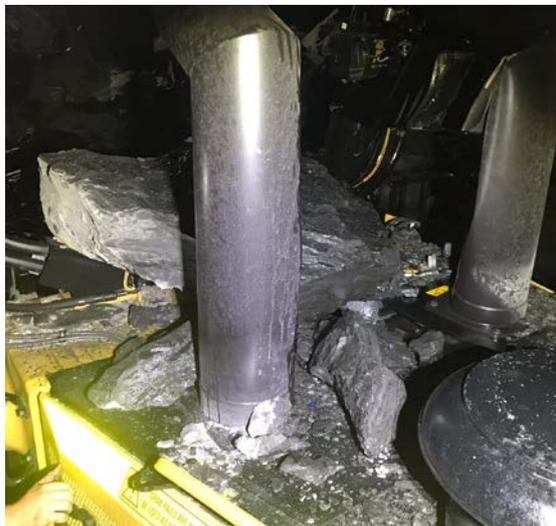
Incident type	Summary	Recommendations to industry
Dangerous incident IncNot0033948	At an open cut coal mine, a dozer was hit with a large rock. In line with the mine procedure, the dozer entered the swing radius of an excavator once the haul truck was driven away. The truck had left without being directed by the excavator operator, who intended to load another bucket into the truck. As the excavator slewed around, it saw the truck had left and stopped. As it stopped, a rock slid off the front of the bucket and landed on the bonnet of the dozer.	Operators must review and should implement the recommendations from safety bulletin SB18-06 Lack of Positive communication .

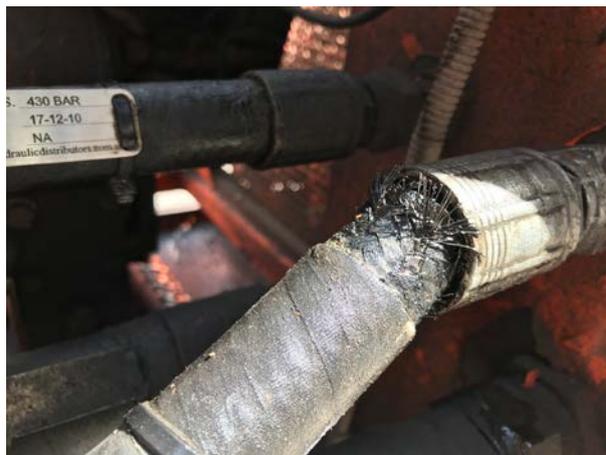
Dangerous incident
IncNot0033937

A worker was sprayed with oil while fault finding a haul truck recovery power pack. The powerpack was not connected to a truck and when it was started, a hose failed, spraying the operator. No injury was reported. It was identified that the power pack did not have any internal pressure relief and relied on the relief valve fitted to the truck.

All hydraulic systems must be protected for over pressure events. When designing pressure relief systems, consideration must be given to all applications and situations when the equipment is used.

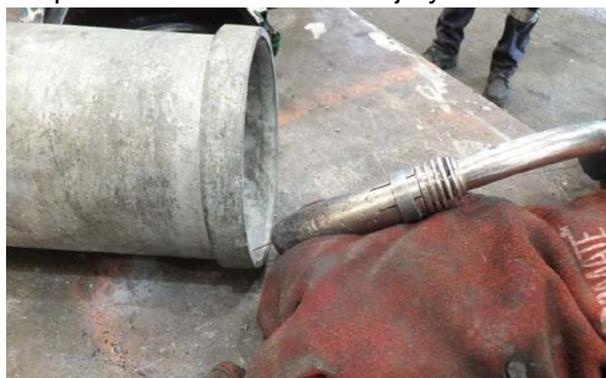
Dangerous incident
IncNot0033939

A worker suffered an electric shock while welding. The shock occurred when the worker steadied the welder hand piece by placing his hand on the bench. The worker was taken to hospital and was cleared of injury.

There has been a recent increase in welding-related electric shocks. Mine operators should verify that workers completing welding activities have identified appropriate earthing points, personal protection equipment (PPE) is dry and they are appropriately trained.

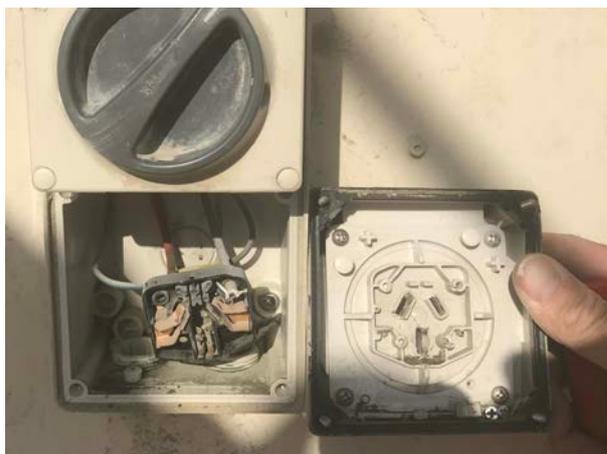
Dangerous incident
IncNot0033916

A contractor preparing to carry out repairs in a hopper suffered an electric shock. The worker was setting up a portable welder and felt the electric shock as he tested the welder. A mine investigation identified that there was no connection to earth on the earth pin of the 15-amp outlet because the back of the outlet had come loose inside the outlet enclosure.

A NSW Resources Regulator inspector attended the mine and issued several s191 improvement notices. Mine operators should verify that workers completing welding activities have identified appropriate earthing points, personal protection equipment (PPE) is dry and they are appropriately trained.

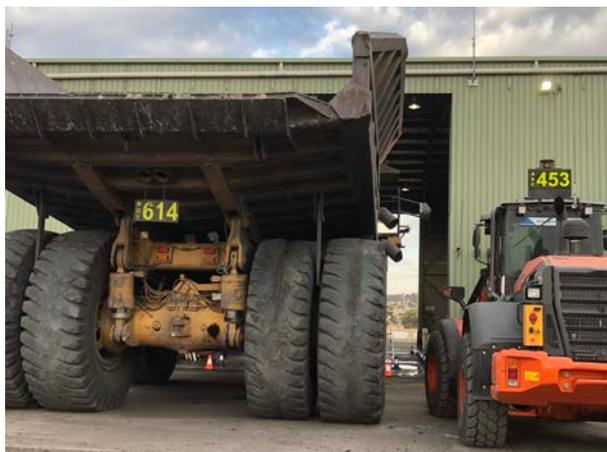
Dangerous incident
IncNot0033933

A piece of glass hit a worker when a haul truck right-hand inner tyre burst in an open cut coal mine. The worker was operating a tool carrier adjacent to a haul truck on the workshop apron.

The life cycle management of tyres should include the changing out of the tyre before failure. Degradation signals that failure is imminent.

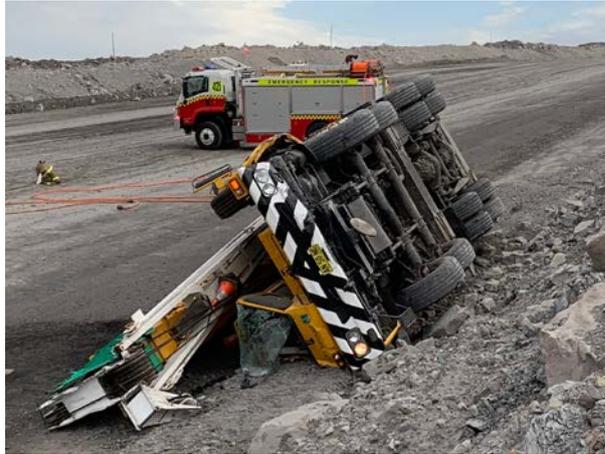
Dangerous incident
IncNot0033929

A 50-tonne slew crane rolled while travelling down a ramp at an open cut coal mine. The incident occurred on the second successive long ramp of the journey. It was reported that the crane lost brake function. The operator attempted twice to slow the crane by steering it into a windrow. No injuries were reported. Workers exited via the windscreen.

NSW Resources Regulator inspectors attended the mine and issued a s195 prohibition notice preventing the crane from being recovered until appropriate risk controls have been established.

Before heavy vehicles are escorted into the mine,

hazards of the travel route need to be assessed including the route to be taken, operating grades and vehicle interaction.

Appropriate means of slowing vehicles should be used to minimise braking including gear selection, exhaust braking and retardation.

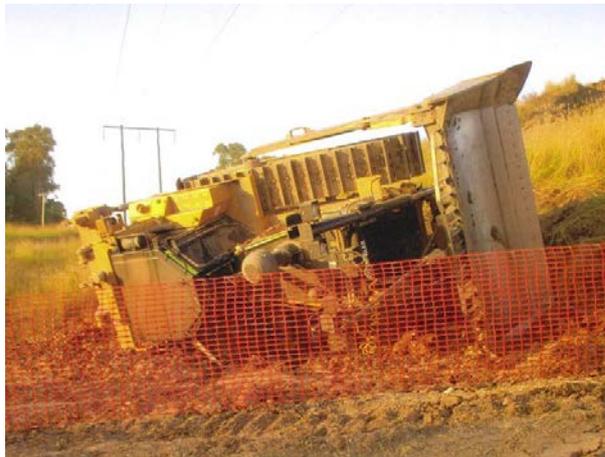
Dangerous incident
IncNot0033917

A dozer pushing dirt on the slope of an old bund slipped sideways and rolled onto its right hand side. The driver exited the cabin and was uninjured.

Operators need to plan work around grades to minimise the amount of work completed on cross grades.

Work area inspections must be completed before beginning work to determine ground stability.

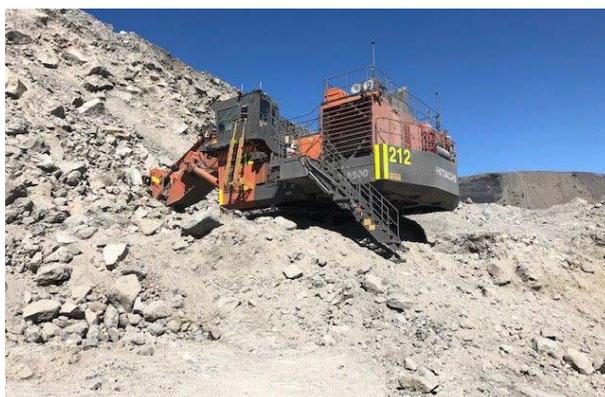
Dangerous incident
IncNot0033910

An excavator was cleaning overblast that was against a 10-metre highwall. While the bucket was low into the material, further material fell onto the bucket. The machine was caught by the material on the bucket. There were no injuries.

A s195 prohibition notice was issued to the mine preventing recovery of the machine until appropriate risk controls had been established.

Ground and slope stability need to be considered when completing any task. The introduction of new risks needs to be assessed and appropriate action taken to reduce exposure.
