INCIDENT ALERT

LOCATION: MARINE & SHIP TO SHORE
ACTIVITY: MAINTENANCE & HOUSEKEEPING
SUB ACTIVITY: N/A

ALERT STATUS: Normal
DATE ISSUED: 19/12/2017 18:30:26
INCIDENT No: 01478

Fall from height into water - BMAPA Alert

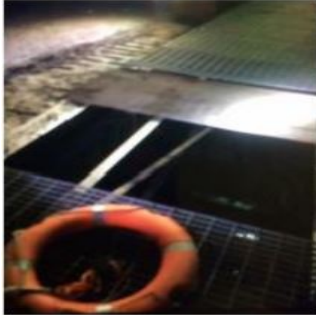
Upon leaving the crane, the deck hand stood on a section of walkway grid on the quayside that had worked loose due to vibrations from the crane. The grid had moved forward and was unsupported on its rear edge so when the IP stood on the unsupported side of the walkway, it pivoted on the central supporting beam resulting in both the individual and the grid falling into the river.

Missing grate

The IP stands on unsecure metal walkway grating that pivots, resulting in the person and grate falling into the water.

- Lack of inspection and maintenance of walkway gratings
- Gratings overlapping with the path of the tracked excavator
- Absence of physically marked exclusion zone
- Control of sub contractors (ships crew).

- Unauthorised person in prohibited area (the action)
- Loose walkway grid (the condition).

- Enforce prohibitive area by including in new pre-discharge procedure and establishing physical demarcation.
- Only named, authorised personnel to be permitted in the prohibited area
- Fix walk way grids so they can't vibrate loose
- Record inspections of walkways as part of pre-discharge procedure
- All personnel to wear life jackets
- Improved rescue equipment and man in water training for all staff.

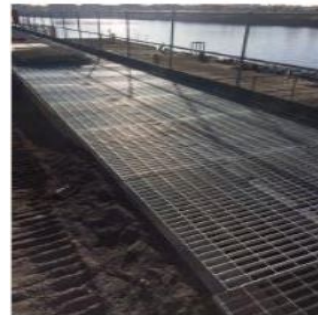
Grating secured - note overlap
