**REPORT OF INVESTIGATION**

**Surface Nonmetal Mine  
(Dimension Stone N.E.C.)**

**Fatal Powered Haulage Accident  
October 19, 2018**

**Montana Rockworks Inc.  
MCGREGOR  
Marion, Flathead County, Montana  
Mine ID No. 24-02226**

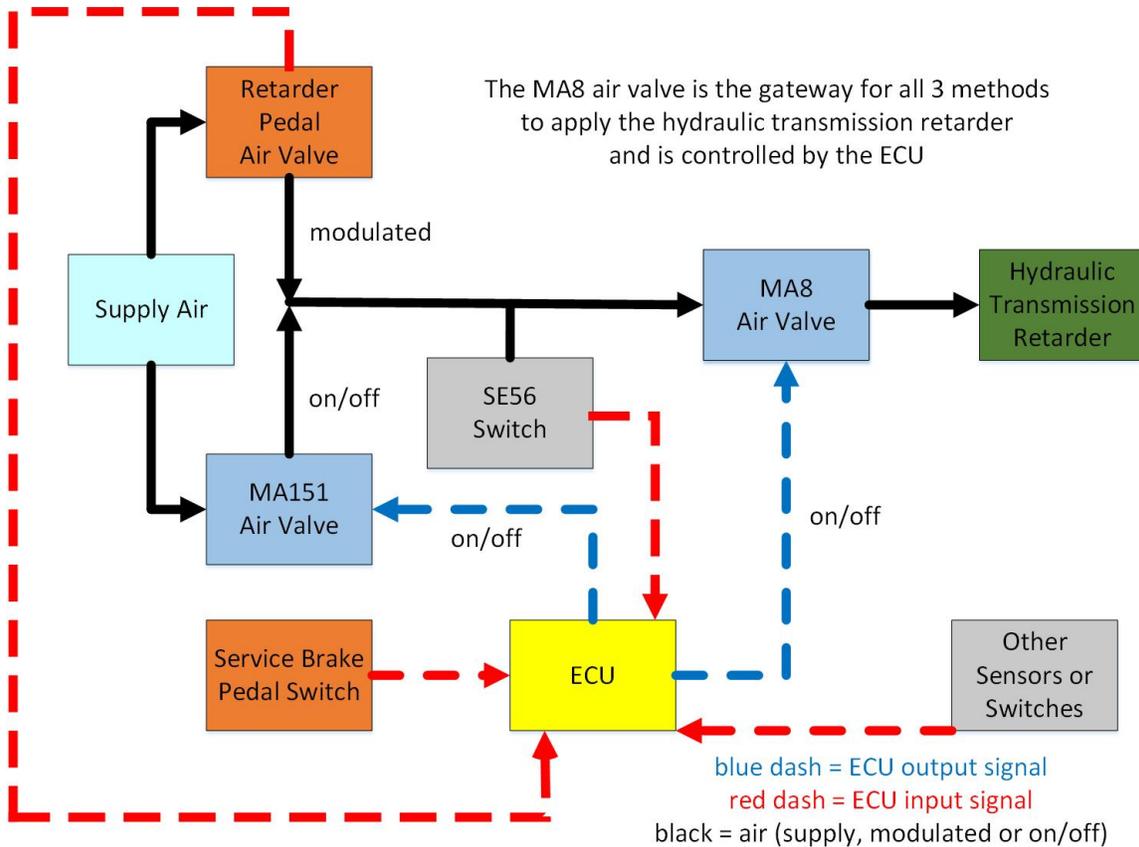
**Figure 1:** Illustration of the Retarder Control Circuit

Figure No. 1 shows the components of the ECU and how they interconnect.

Investigators were not able to test the performance of the retarder system due to damage to the truck, but they did test some components of the system’s control circuit.

Investigators encountered the following defects with the retarder system: the inability of a solenoid to correctly control the MA8 air valve made all three methods of applying the transmission retarder ineffective; and a defective SE56 switch that would not allow the ECU to recognize that the truck driver was pushing the retarder pedal, making that option ineffective even if the MA8 air valve operated properly. The defects in the Retarder System contributed to the accident.
