Significant Incident Report No. 272

Subject: Sinkhole in open pit floor engulfs mine vehicles after collapse of backfilled stope

Date: 11 January 2019

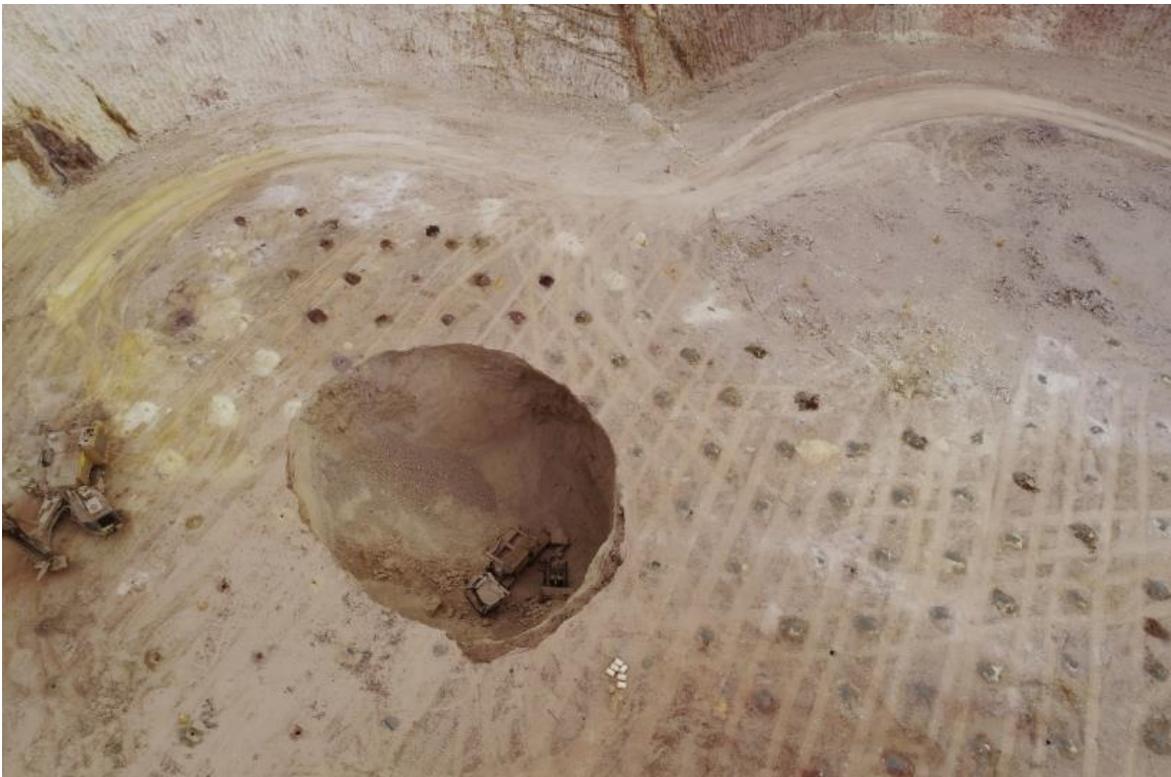
In October 2018, a working pit floor subsided into a backfilled stope, forming a 13 metre deep sinkhole. The stope had previously self-mined to near surface and had been backfilled in stages since 2016. At the time of the incident, surface drill and blast activities were occurring in the vicinity. The subsidence event resulted in the loss of an integrated tool carrier and an explosives truck that were parked on the blast pattern. A number of charged blast holes were also engulfed in the sinkhole.

Open sinkhole with mine vehicles

- At the time of subsidence, the backfilled underground workings were not treated as a void allowing work to be undertaken above an area of unknown stability.

- A risk assessment in December 2017 identified the stope void as a hazard; however, recommended controls were not adhered to.
- The decision was made in July 2018 to move from strict void management protocols to standard mining practices on the (incorrect) assumption that the pre-2018 backfilled section of the stope void was tight-filled.
- Inadequate change management associated with the decision to move to normal operational practices.
- The exact cause of subsidence was undetermined due to lack of access, records and uncertainty about the void shape and fill material.

- Risk assess conditions within backfilled stopes and factor the potential for change over time.
- Conduct rigorous assessment of all failure mechanisms for voids and filled underground stopes as part of the pit design process (i.e. pillar collapse in the vertical or horizontal direction, backfill collapse).
- Ensure backfill records are available and include volume calculations, material characteristics and behaviour.

- Ensure all underground workings relevant to the proximity of active open pit work areas are marked on all working plans and void management processes are in place and applied.
- Adopt rigorous change management processes in critical decisions regarding operational practices, especially around voids (e.g. conduct rigorous site investigations to support any change in management strategies).
- Develop safe working practices that do not presume that any stope is tight-filled.

- Monitor and record any change in underground conditions below open cut workings, and take further action as/when appropriate.
