Serious injury

Incident date: 4 July 2018

Event: Serious injuries at an underground coal mine

Location: Clarence Colliery, Clarence NSW

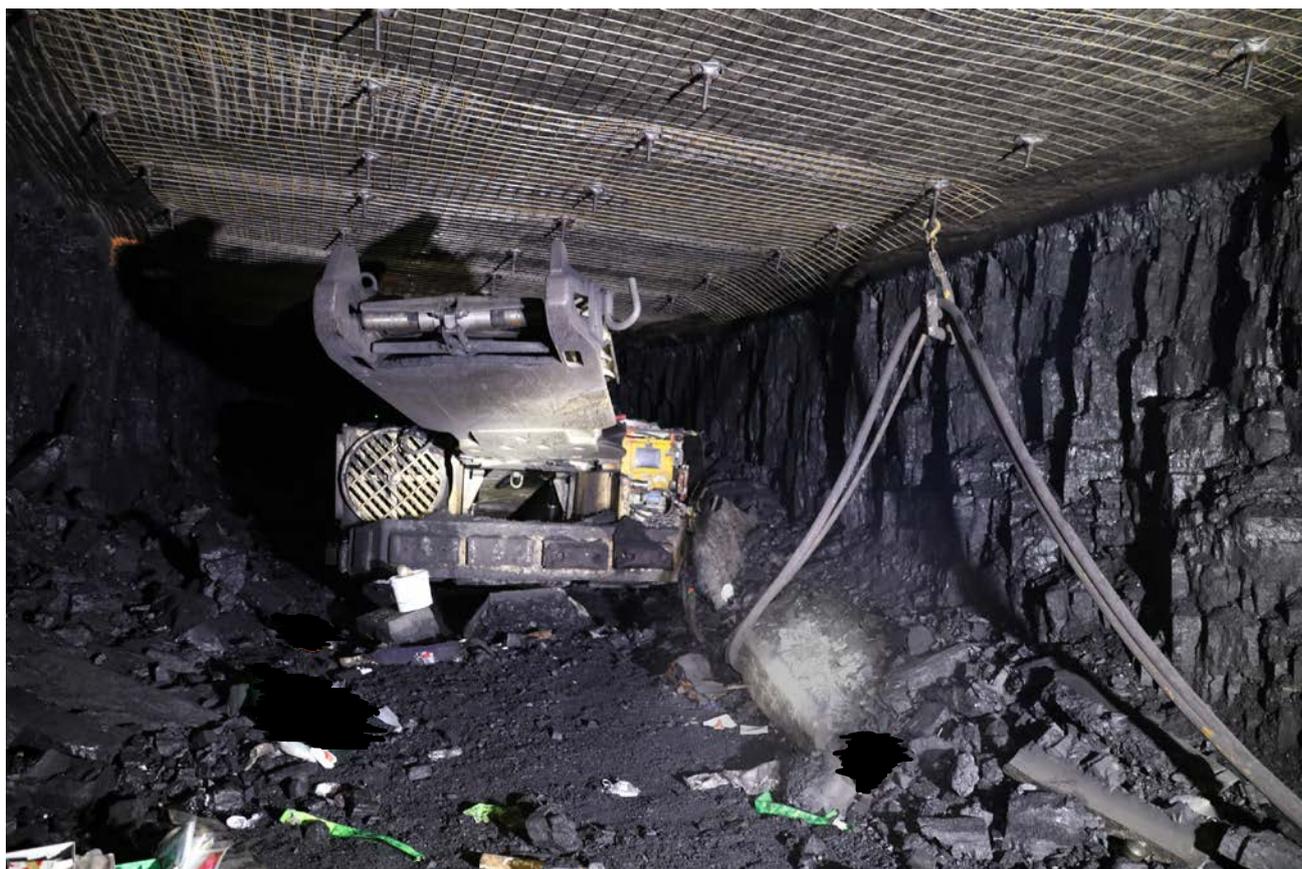
Photo 1: Failure of right rib in underground heading. Picture by Resources Regulator investigators.

At 9.10 am on Wednesday 4 July 2018, a section of the right rib of the heading failed (rib spall) in 808 North Panel and struck two mine workers, a father and son.

The 808 North Panel is a development panel on first workings. At the time of the rib spall, the underground heading was at the end of the development sequence with the continuous miner to be trammed back to do the breakaway and mine the cut-through to form the coal pillars. The piece of rib coal that struck the driver weighed about 500 kilograms.

A risk-based approach for rib hazard identification and assessment is crucial.

Rib conditions must be assessed in three phases during the life of mine workings as follows:

- as early as possible during the cutting of the development faces
- continue through the formation of the pillars and while the pillars stand because there is often time-dependent movement
- during and after secondary extraction as stress abutments develop in pillar extraction.

Competent geotechnical personnel should carry out assessment of rib stability should be carried out, which should consist of, at least, detailed rib mapping throughout the life of the workings and installation of pillar rib instrumentation such as extensometers and instrumented rib bolts.
