Close Call – Exposure to potential electrical shock

22nd May 2019

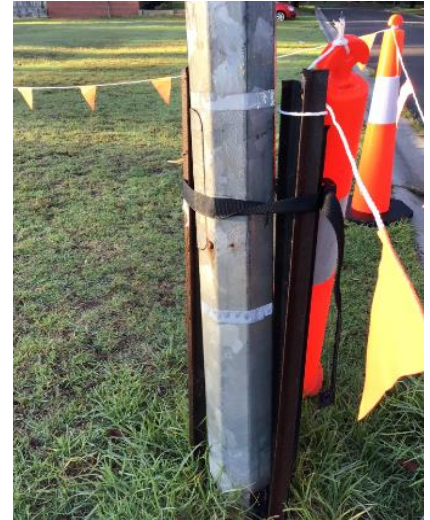
A street light pole (direct buried type) was found to be rusted at ground level, was on a lean and at risk of falling over. To prevent the pole from falling over it was decided by the Supervisor and Electrician to drive four steel star pickets into the ground and tie the pole to the steel star pickets to provide temporary support. In doing so the star pickets narrowly missed the underground energised electrical cable.

The Supervisor and Electrician did not properly assess the risk. They incorrectly assumed the cable location, and the conduit type prior to driving the metal stakes into the ground.

- A proper risk assessment must be conducted to ensure effective controls are in place for each identified hazard to eliminate or mitigate the risk.
- If a service is identified within the area (e.g. gas, water, electricity), then a Dial Before You Dig or another safe system of work is required, such as Permit To Work (PTW). PTWs are required for activities requiring isolation and/or lockout of live equipment or live energy sources.
- Alternative above-ground methods would have eliminated the need to penetrate the ground with steel star pickets.
