Week ending 4 July 2018

This incident summary provides information on reportable incidents and safety advice for the NSW mining industry. To report an incident to the NSW Resources Regulator: phone 1300 814 609 24 hours a day, 7 days a week.

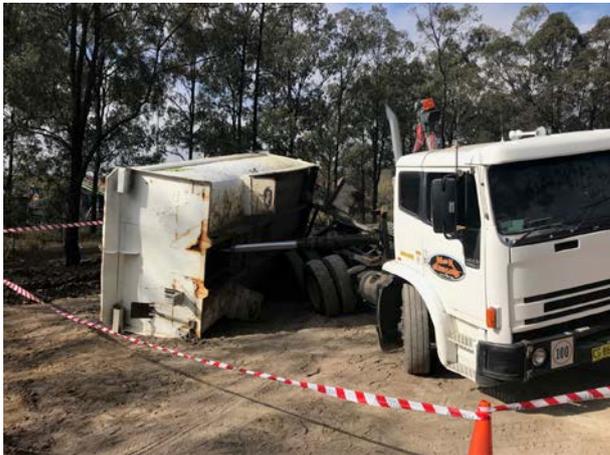
Incident type	Summary	Recommendations to industry
Dangerous incident SinNot-2018/01059	<p>The body of a tip truck failed and fell off a truck. The road-registered truck was relocating gravel on a mine site.</p>

<p>In setting out the control measures to manage risks associated with plant and equipment, the mechanical engineering control plan must take into account (among other matters):</p> <ul style="list-style-type: none"> → The introduction of plant onto a site. → The operation of plant to ensure that it is fit for purpose. → The identification and rectification of defects. <p>Road registered plant is not precluded from these considerations when operating on a mine site.</p>

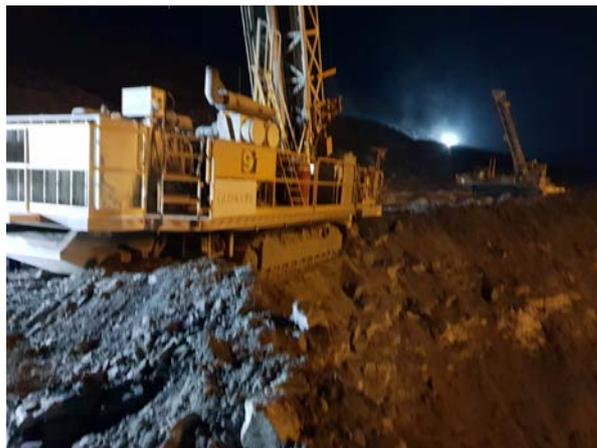
A drill rig breached a windrow adjacent to the edge of a 50 m highwall.

It was reported the drill operator was focused on positioning the machine at the time and was unaware of the drills proximity to the highwall.

Mine operators should review the management and supervision of trainee drill operators to rigorously manage their exposure to high-risk activities, including drilling the face row near a high wall edge and operating at night or in poor visibility.

Mine operators should review the application of positioning technology to warn of proximity to highwalls and provide an additional layer of protection.

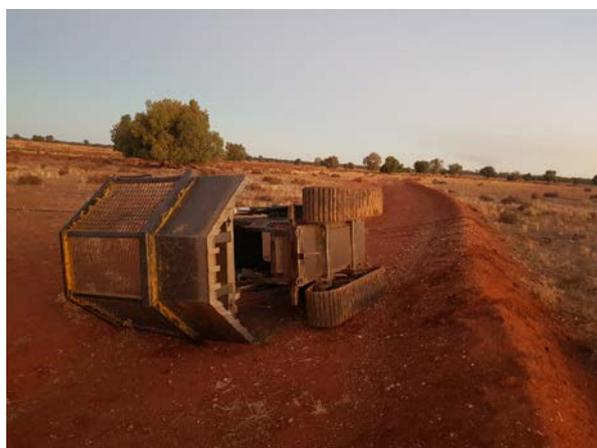
A multi-terrain skid-steer loader rolled onto its side. The machine had crested a windrow and turned.

When attachments are designed, an assessment of the effects on the stability of the machine must be completed. This should be reviewed by the mine while undergoing introduction-to-site checks.

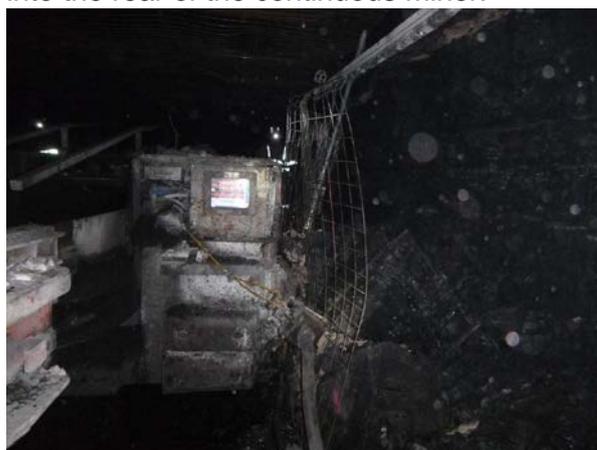
Two pieces of rib fell into a work area on a continuous miner while a worker was roof bolting. One worker was installing roof bolts on the right-hand side of the miner when a piece of rib (1 m long x 0.4 m deep x 2 m high) failed vertically, hitting the continuous miner. Five seconds later a second piece dislodged from the rib inbye, knocking the mechanical guard into the rear of the continuous miner.

When strata conditions change or mining commences in new areas, the risk assessment and controls identified should be reviewed and the principal hazard management plan updated.
