INCIDENT ALERT

ALERT STATUS: High Potential
DATE ISSUED: 04/06/2018 15:29:23
INCIDENT No: 01491

TITLE

Front End Loader in water pit incident

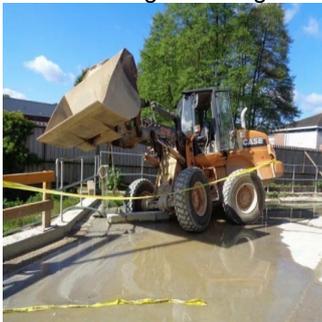
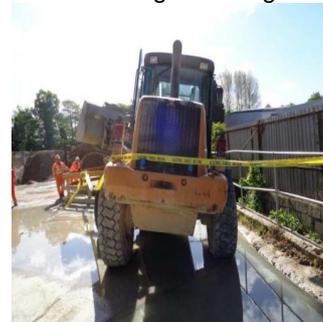
A front end loading shovel (FEL), entered a small water pit when the operator drove over a storm drain cover. This pit was situated along one edge of the yard and was adjoining a storm drain that connects to a nearby stream. The weight of the FEL caused the drain cover to collapse which in-turn caused the FEL to lean at a dangerous angle, presenting the potential of it tipping over.

- Limited all-round visibility – operator failed to see the drain cover under surface water
- Lack of adequate edge protection around water pit
- FEL fitted with standard vision mirrors only - wide angle convex mirrors should have been installed as well
- Contracted operator did not possess MPQC card or evidence of competencies concerning the operation of a FEL.

- Edge protection around water pit to be improved FEL to be fitted with wide angle convex mirrors as well as standard vision mirrors
- An All Round Vision Assessment will be completed.
- Remind operators to never enter flooded areas unless they know what is beneath the surface
- Checks to ensure that all operators have undergone the required training and possess recognised competencies such as MPQC.
