## Week ending 27 June 2018

This incident summary provides information on reportable incidents and safety advice for the NSW mining industry. To report an incident to the NSW Resources Regulator: phone 1300 814 609 24 hours a day, 7 days a week.

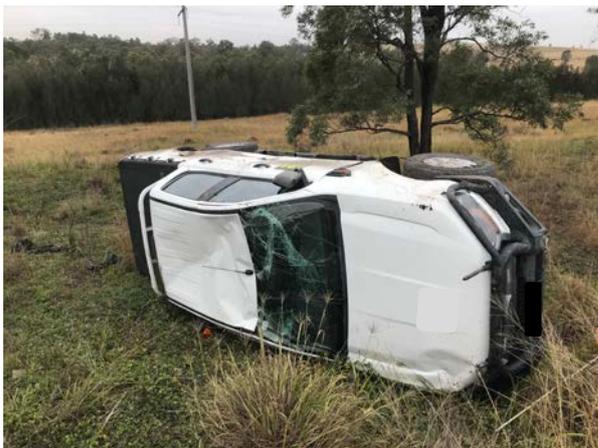
Incident type	Summary	Recommendations to industry
Dangerous incident SinNot-2018/01028	<p>A light vehicle rolled after contacting a light vehicle bund. The driver reported having a microsleep while returning to the muster area at the end of night shift. The operator had just had woken up from a fatigue break that was taken in the vehicle.</p>

<p>The fatigue management procedure should detail the requirements when operators take fatigue breaks in vehicles to manage the risk of subsequent microsleeps.</p> <p>When working in remote areas workers should be in direct communication with supervisors.</p>

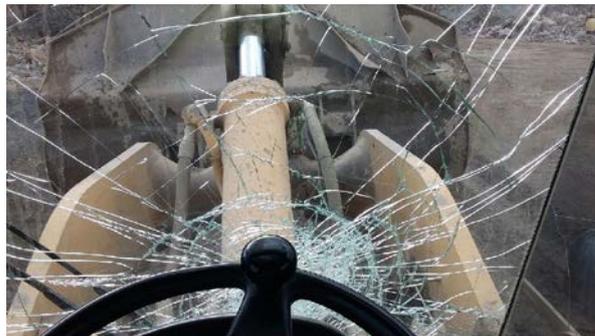
The windscreen of a loader smashed when a rock hit it. An excavator was operating at the top of a face casting material in a single pass down four benches to the pit floor. The loader then took material to a crusher.

The incident was not reported when it occurred because it was thought not to be a reportable incident.

Work methods and the controls used must consider the risk of falling material and locations of people.

Mines should refer to the recommendations in safety bulletin [SB18-05 Increase in shattered windscreens on mobile plant.](#)

*Work Health and Safety (Mines and Petroleum Sites) Act 2013* section 15 requires mine operators to report incidents. The Resources Regulator website has numerous resources to assist determining what incidents are notifiable and the process. Supervisors should be trained in incident management including notification.

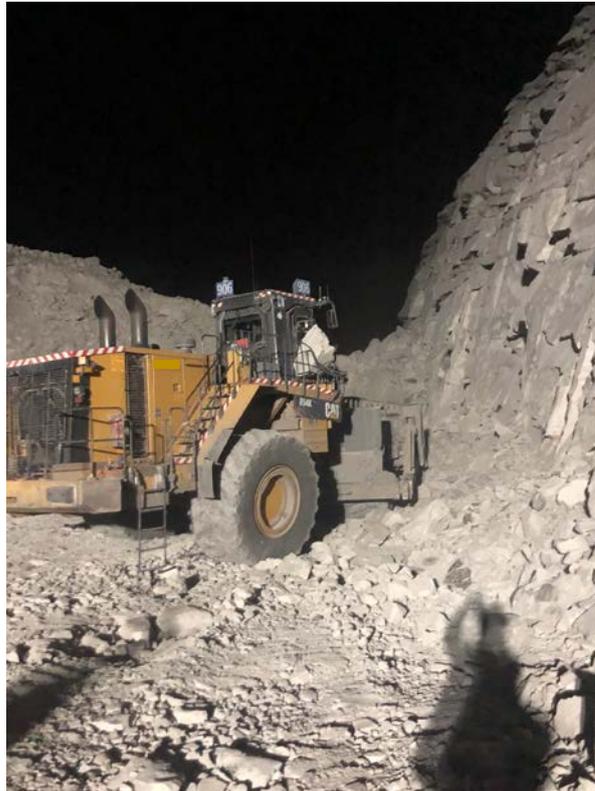
A rubber-tyred dozer was damaged when a rock fell from a highwall. The dozer was working underneath the pre-split high wall conducting clean-up work for the face shovel. A rock fell from the high wall and hit the right-hand side of the dozer. The impact caused

damage to the electrical systems on the machine, shutting it down and disabling the radio. The operator had to flag down a haul truck operator for assistance.

Risk assessments must be conducted establishing appropriate controls for hazards associated with highwalls before working under them.

Workers must remain vigilant and not rely on other workers' inspections when working near highwalls.

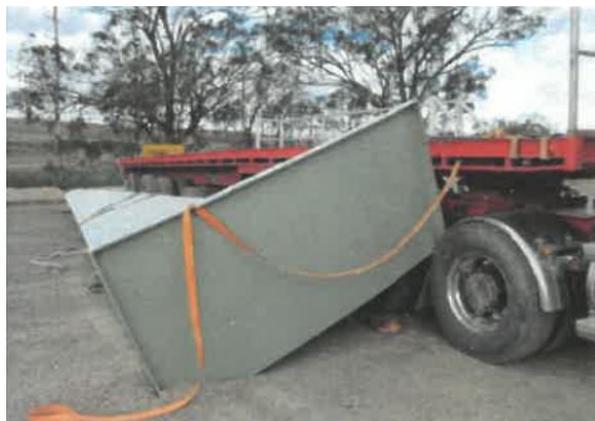
A large, steel component fell from a truck while being secured. The truck driver was on the opposite side of the vehicle at the time.

Loading and unloading procedures should include the provision for cranes to continue to support a load until it is adequately secured to the truck or sitting stable on the unloading area.
