## Week ending 6 June 2018

This incident summary provides information on reportable incidents and safety advice for the NSW mining industry. To report an incident to the NSW Resources Regulator: phone 1300 814 609 24 hours a day, 7 days a week.

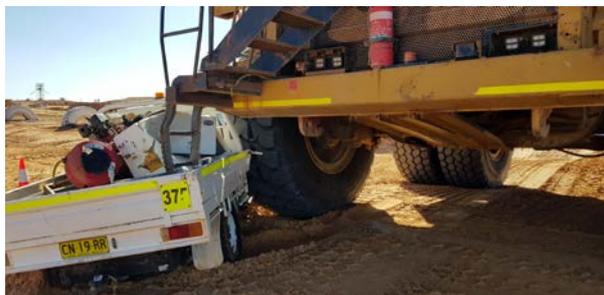
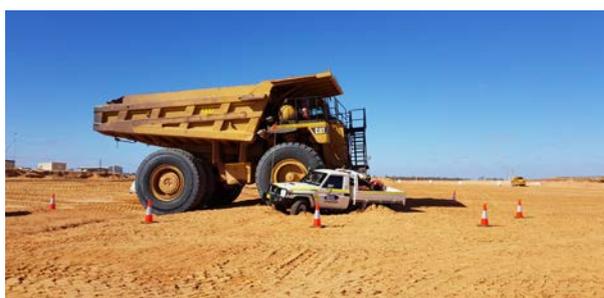
Incident type	Summary	Recommendations to industry
Dangerous incident SinNot - 2018/00896	While carrying out maintenance, a winder main skip made contact with a davit arm. The arm had been used to prepare for maintenance and when the winder was operated it struck the davit arm.	Any item that has the potential to enter the shaft or be left in the shaft should have a way of being secured. Checks that all items have been secured should be included in procedures before a winder is returned to service following maintenance.
Dangerous incident SinNot - 2018/00887	A haul truck hit a parked light vehicle. A worker had driven the light vehicle to the front of the parked haul truck. The worker then started to drive the haul truck to a workshop and made contact with the light vehicle. No other person was in the vicinity.	Where light vehicles and heavy vehicles are expected to interact, designated parking areas for each type should be allocated, marked and, where possible, segregated. Pedestrian access and interactions with vehicles should also be considered.

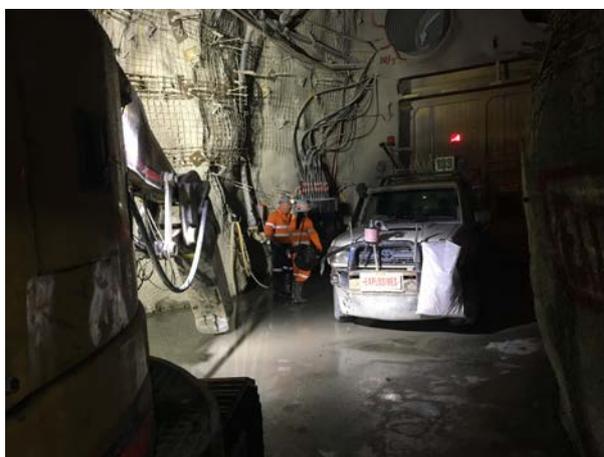
Dangerous incident  
SinNot - 2018/00879

An excavator was tramping underground when it hit a light vehicle. The excavator was carrying a hydraulic hammer at the time. As it tramped around a corner, the operator did not see the parked light vehicle.

Mine transport management plans and transport rules should consider the risk of heavy equipment moving around the mine while carrying loads or attachments.

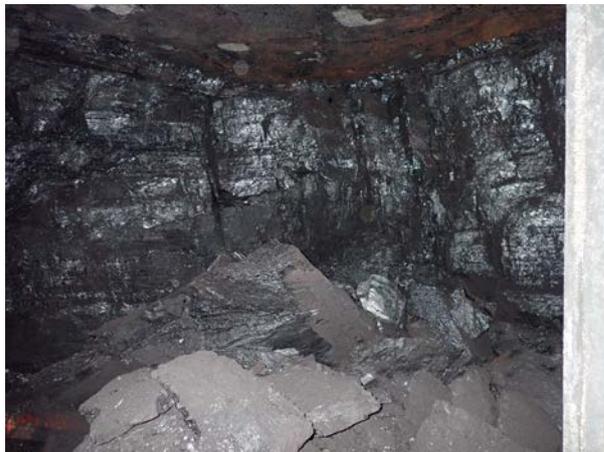
Dangerous incident  
SinNot - 2018/00877

A large pressure bump occurred in a development roadway. Workers on the continuous miner at the time were peppered with coal on a continuous miner. A dust storm followed. The rib moved and parts of the rib were fractured.

All mines must assess the risk and implement specific control measures, following the hierarchy of controls, for mining induced seismic activity (clause 44B WHS (Mines and Petroleum Sites) Regulation 2014).

Where control measures do not sufficiently control the hazard they must be reviewed and, as necessary, revised.

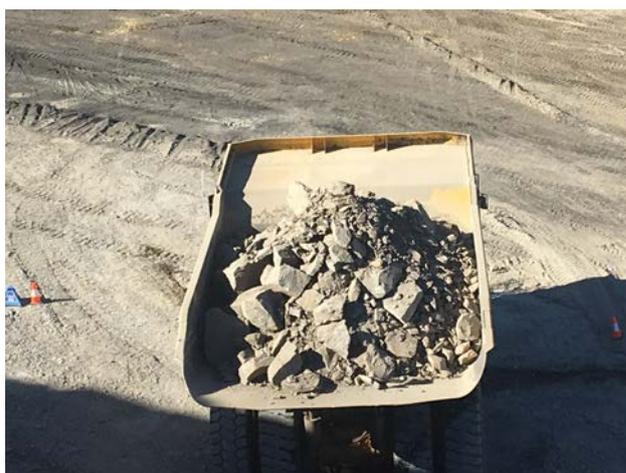
Dangerous incident  
SinNot - 2018/00873

A worker suffered suspected neck injuries when an excavator was loading a dump truck. The mounts on a hydraulic tank on the dump truck failed during the incident.

When conducting risk assessments, developing operational procedures and training packages for consideration should be given to material size and forces encountered during loading.

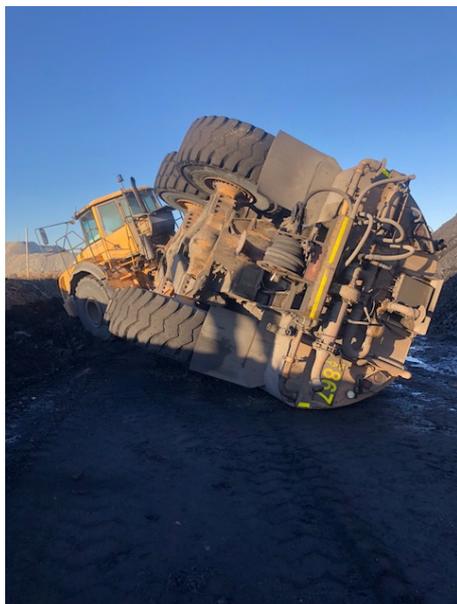
Dangerous incident  
SinNot - 2018/00872

An articulated water cart trailer overturned while backing into position to spray cannon on the ROM. The trailer backed onto a windrow and overturned onto right hand side.

There have been repeated cases reported to the Resources Regulator of articulated vehicles overturning recently. The stability of articulated vehicles is a known risk and mines should manage this. Consideration should be given to factors such as (but not limited to):

- operating grades
- uneven surfaces (holes, rocks, foreign material)
- tipping of loads
- hang-up of loads
- movement of loads
- speed of operation
- tyre failure
- movement of water and unbalancing of loads in water carts.

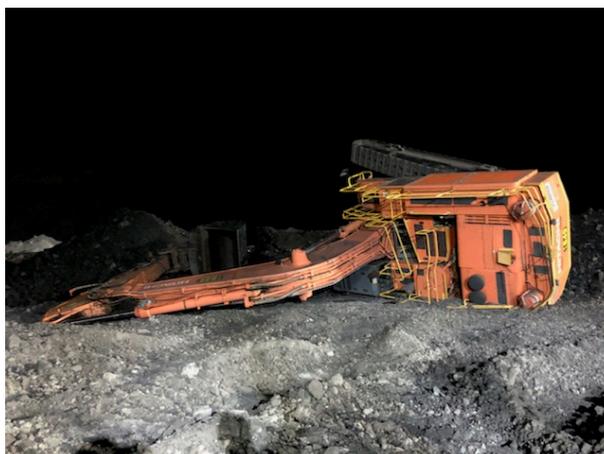
Dangerous incident  
SinNot - 2018/00860

An excavator overturned while cleaning up a bench. The bench was 1.5m high.

Equipment operators must maintain situational awareness and remain vigilant of the risk of machine roll overs

The circumstances of this incident also underpins the importance of wearing seatbelts as a mitigating control.

When planning tasks and travel paths, supervisors must consider roll over hazards.

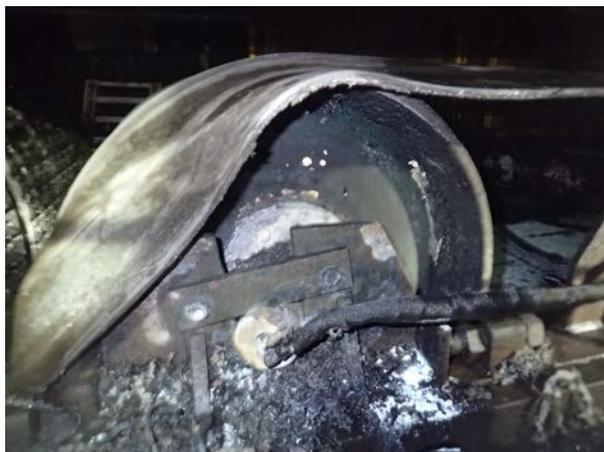
Dangerous incident  
SinNot - 2018/00856

A fire occurred underground when a pulley bearing in a loop take-up collapsed. A technician saw smoke while completing an inspection and raised the alarm.

Controls should be in place to monitor for fires on conveyors including:

- routine belt inspections

- condition monitoring
- maintenance programs to ensure high standards of housekeeping around these installations
- CO detectors in a designated location
- adequate firefighting equipment available.
