Mines Safety Bulletin No. 164

Subject: Wheels detaching from graders

Date: 17 April 2019

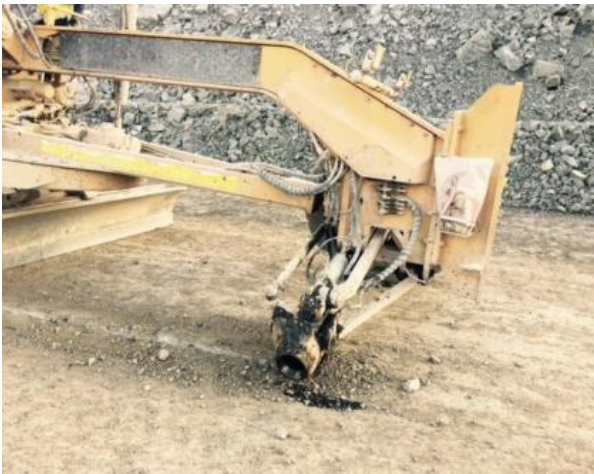
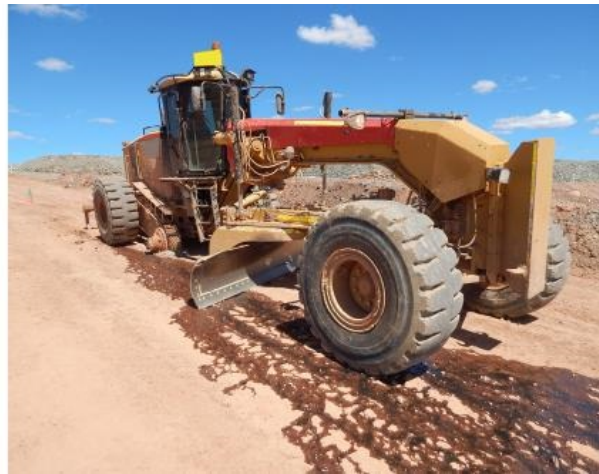
The Department has received reports of potentially serious incidents involving graders when either a front steering wheel or a driving wheel experienced catastrophic failure of its stub axle, resulting in the wheel suddenly detaching during operation. Recent incidents include:

These incidents were injury free. In all cases there was temporary loss of control of the machine and the detached wheel rolled away in an uncontrolled manner. The modes of failure, the physical root causes and contributory factors in all these incidents were found to be similar.

Example of a steering wheel failure and a driving wheel failure.

- Ensure stub axles are periodically inspected for surface cracks and other defects using OEM approved Non Destructive Testing (NDT) methods, at the OEM recommended intervals and by competent inspection personnel. When defects are observed, apply OEM recommended discard criteria.

- Use only genuine (OEM approved) replacement parts for shaft group assemblies.
- Ensure maintenance management systems adequately track and manage fatigue limited components such as stub axles.

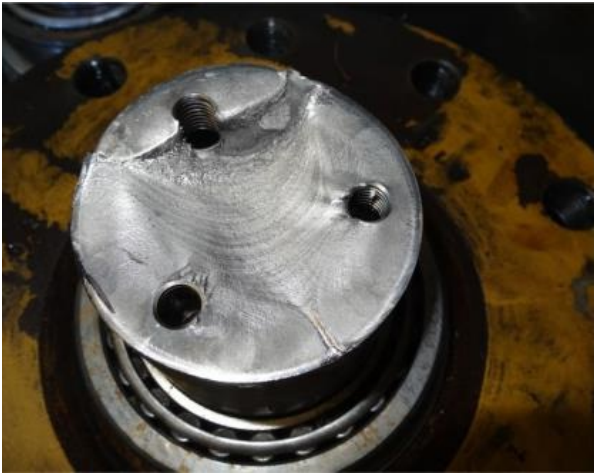
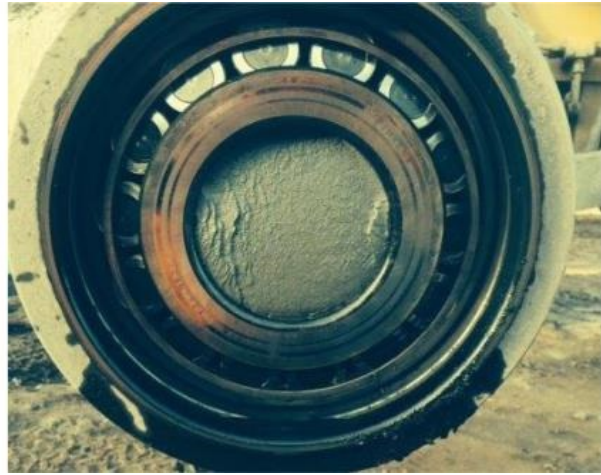
- Poor hazard awareness and reporting - some sites fail to report such incidents to the Department.
- Poor operating practices that cause excessive loading of the stub axles can also contribute to their premature failure. These include:

- operating on sharp turns and tight switch-backs
 - exceeding the oscillation stop limits of axles in rough terrain (total range of 32 degrees)
 - imposing excessive speed and shock loads to the grader front end (e.g. from excessive or sudden braking, or impacts with rocks and depressions in the road).

Progressive fatigue failure on a steering stub axle and a steering stub axle failure due to suspected shock load.
