## INCIDENT ALERT

LOCATION:	AGGREGATE DREDGER	ALERT STATUS:	Normal
ACTIVITY:	MAINTENANCE & HOUSEKEEPING	DATE ISSUED:	16/10/2017 11:17:36
SUB ACTIVITY:	N/A	INCIDENT No:	01474

#### Mechanical handling injury on dredger due to maintenance regime

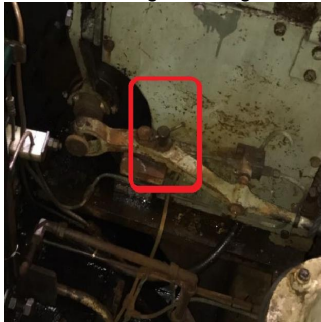
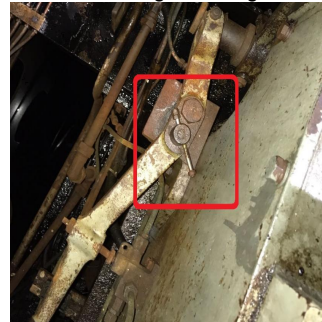
The pin for the turning gear had seized due to a sea water leak from the air cooler drain dripping on the pin causing it to become corroded.

When the Duty Engineer tried to release the pin (unaware that it was seized), he strained his left shoulder. The injury required medical assessment, which diagnosed rest and the use of painkillers.

Inadequate inspection and maintenance regime in place to ensure the satisfactory working of the specified shipboard equipment.

Planned Maintenance Job Card added for the Turning Gear Pin, requiring inspection on a frequent basis and periodic lubrication.

Risk assessment and Safe Working Practice for the operation reviewed to ensure that the hazard of "engaging and disengaging the turning gear pin" is considered.
