Week ending 21 November 2018

This incident summary provides information on reportable incidents and safety advice for the NSW mining industry. To report an incident to the NSW Resources Regulator: phone 1300 814 609 (24 hours a day, 7 days a week).

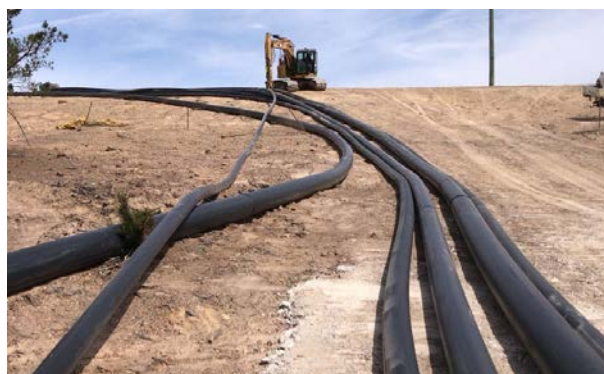
Serious injury
SinNot-2018/01913

A worker was injured when poly pipe hit him. The poly pipe was being lifted and dragged into position using excavators. After moving three pipes, the fourth pipe being moved hit the worker. The worker's knee and shoulder were injured when he fell to the ground.

When poly pipe is being moved, the stored energy and potential for sudden release (spring back) must be taken into account in task procedures. Clear and defined 'no-go' zones must be developed to protect workers from sudden releases of energy.
