## Week ending 11 October 2017

This incident summary provides information on reportable incidents and safety advice for the NSW mining industry. To report an incident to the NSW Resources Regulator: phone 1300 814 609 24 hours a day, 7 days a week.

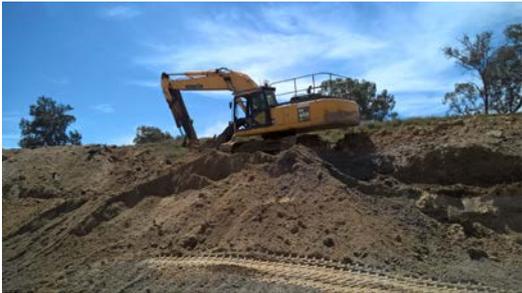
Incident type	Summary	Recommendations to industry
Dangerous incident SinNot 2017/01622	<p>While an excavator was in the process of moving a 3 m log from sand in a pit, the log slipped and went through the excavator windscreen. It landed on the cabin travel controls. The operator suffered minor lacerations to his fingers.</p>

<p>Mine operators are reminded to use the hierarchy of controls when considering risks associated with repetitive tasks.</p> <p>Mine operators are also reminded to reassess the risks when circumstances change and consider whether equipment is fit for purpose.</p> <p>Operators should consider the recommendations in Safety Alert <a href="#">SA 05-04 Injury to excavator operator</a>.</p>
Dangerous incident SinNot 2017/01620	<p>A truck was driving under a coal handling preparation plant bypass coal bin while the tray was up. The track hit the beam on the coal bin.</p>	<p>Mine operators should review the procedure for response to truck tray-up alarms and ensure that this is included in their truck operator training packages.</p> <p>Mine operators should ensure, through pre-start and other periodic inspections, that engineering controls, alarms and warning devices are operating correctly before operating plant. Refer to section 4.2 of MDG 15 <a href="#">Guideline for mobile and transportable equipment for use in mines</a>.</p>
