WEEKLY INCIDENT SUMMARY

Week ending Friday 6 September 2019

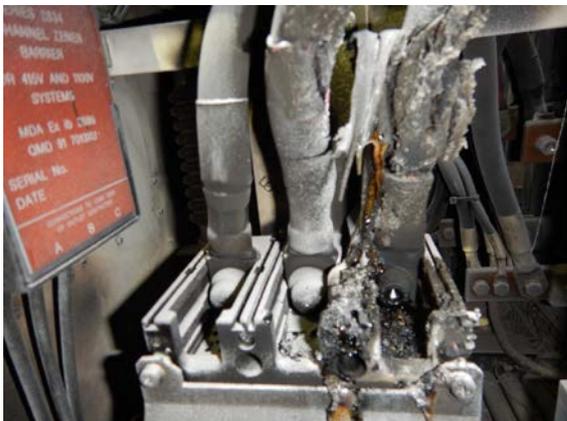
INCIDENT TYPE	SUMMARY	RECOMMENDATIONS TO INDUSTRY
Dangerous incident IncNot0035455

<p>An electrician was going to a transformer following an overload trip on a supply circuit breaker to a DCB in a development panel when he smelled smoke.</p>	<p>Mine operators should review load flows and protection studies when the operating conditions change, resulting in changes to equipment loadings.</p> <p>Mine operators must review the service life of all circuit breakers considering the operating conditions and clearance of fault conditions.</p>

The miner had previously tripped on overload multiple times and on this occasion tripped back to the transformer. It appears there was arcing on the circuit breaker, which led to a fire. An electrician used a fire extinguisher to extinguish the fire.

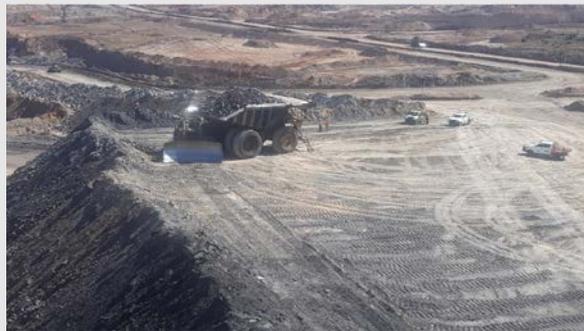
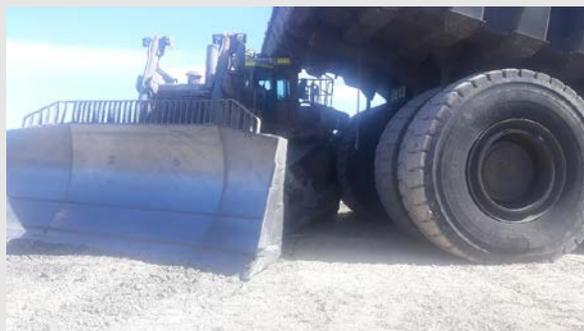
Dangerous incident
IncNot0035463

A dump truck reversed into a dozer on a tip head. No injuries were reported and only minor damage was reported. The truck had a broken reversing mirror. The dozer was moving at the time.

Mine operators must consider the appropriateness of proximity detection systems to prevent machine interactions.

Mine operators should periodically review and retrain workers about understanding positive communication between operators using large equipment.

Equipment defects must be reported and systems should be put in place to stand equipment down if it is unsafe to use.

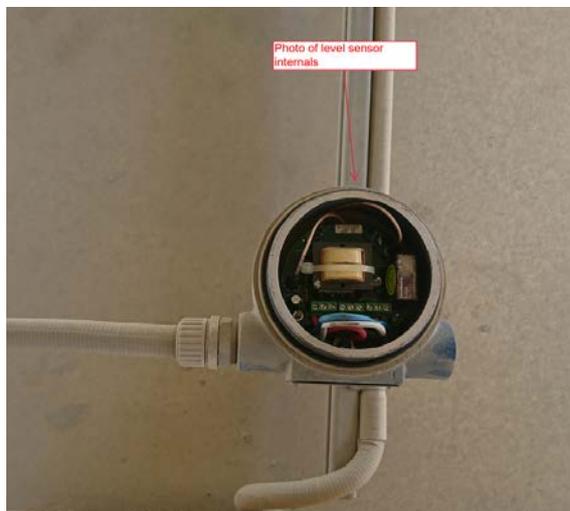
Dangerous incident
IncNot0035466

A large surface diesel fuel tank float level switch failed and during fault finding to investigate the issue, an electrician removed the level switch cover without isolating. The worker reported suffering an electric shock.

Workers should always verify their isolation by dissipating the energy and testing for dead before starting a task. Mine work authorisation systems should include details of the isolation requirements and provide the required information to allow tasks to be carried out safely.
