Coal mine worker fatally injured performing maintenance on a large excavator bucket

Mines safety alert no. 347 | 22 September 2017 | Version 1

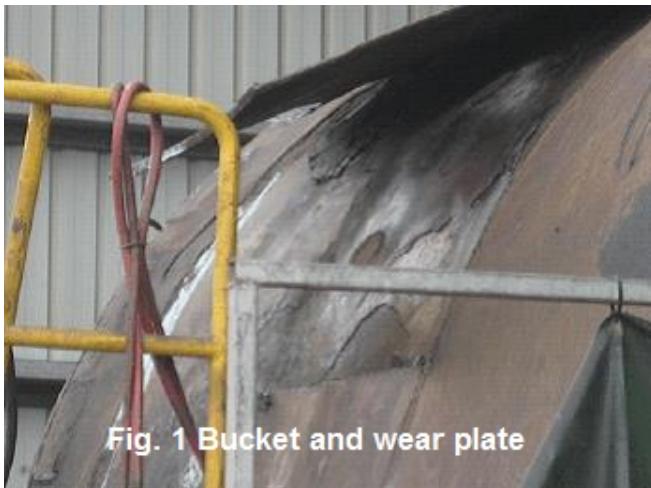
A coal mine worker, who was fatally injured while carrying out repairs on a large excavator bucket (Fig. 1), had been arc air gouging a large wear plate on the bottom of the bucket so it could be removed in small sections.

Fig. 1 Bucket and wear plate

While the exact cause of the accident has not been determined at the time of publishing this alert, the stored energy in the plate, and the resulting uncontrolled spring action of the plate, impacted on the coal mine worker causing fatal injuries.

1. Review the safety and health management system, including the following:
 - a. Any procedures for the identification of stored energy situations
 - b. Any standard operating procedures and associated controls for hot work, cutting and welding.

2. Develop specific work instructions for dealing with similar wear packages.
3. Ensure any permit systems include controls for stored energy hazards.
4. Ensure 'line of fire' is identified.

5. Ensure tasks that may identify critical hazards are fully assessed by appropriate persons.
6. Make persons carrying out similar tasks aware of the extent of the stored energy hazard.

7. Review and assess potential risk from different types of wear packages fitted to buckets.
8. As part of bucket repair tasks ensure previous repair history is assessed before commencing work.

9. Conduct comprehensive non-destructive testing to identify the condition of the bucket and include findings in the task assessment.
