Truck body rolls while tipping

9 February 2018

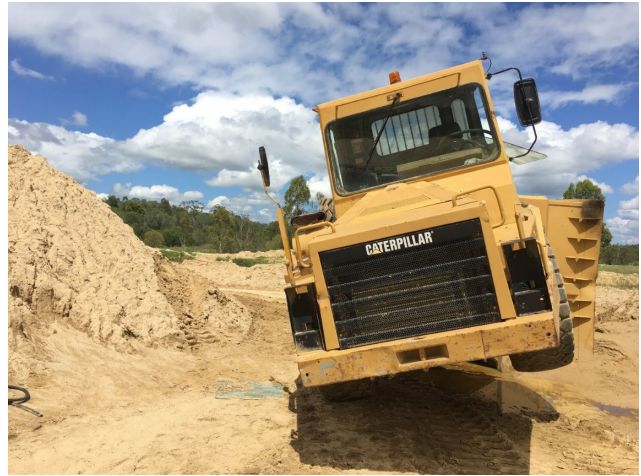
The operator of an articulated dump truck was tipping overburden in a quarry when he backed up onto a slight rise and the body of the truck rolled onto its side. The cabin remained upright and the operator was not injured as he was wearing his seatbelt.

We recommend that all sites review tasks that involve the use of mobile equipment, particularly on uneven, unstable or wet ground. You need to ensure that:

- **Operators are trained and competent to operate the equipment.**
- **Particular care is taken when operating fully articulated vehicles on cross slopes.**
- **Speed is reduced to match the conditions, particularly following wet weather.**
- **Take particular care when operating the vehicle as a water cart. Check the tank has baffles.**
- **Vehicles are not overloaded.**
