PROTECTA SHOCK ABSORBING LANYARDS

RECALL NOTICE

November 1, 2011

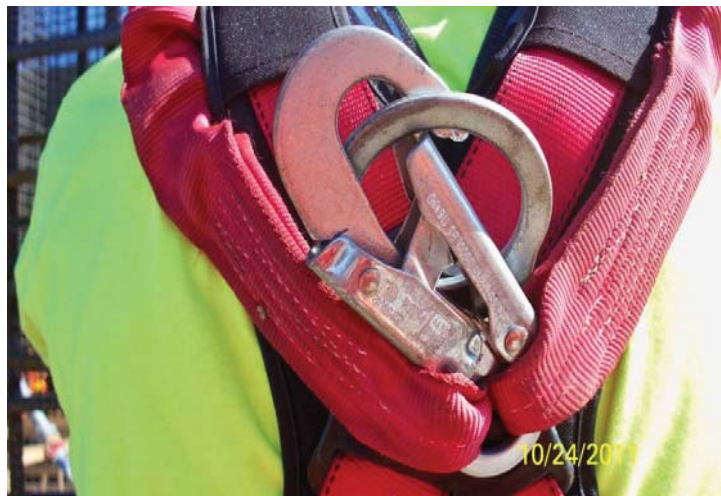
In a particular configuration when the twin lanyard legs are pulled upwards simultaneously and the snaphook gets compressed against the d-ring, the combination of forces acting on both the locking mechanism and the gate opening of the snaphook may cause the snaphook to disconnect from the d-ring. (See photo below)

The identified reason for the inadvertent disconnection is the combination of a particular style locking snaphook together with twin elastic lanyard legs attached directly to the eye of the snaphook. Although there have been no reported falls or injuries associated with the use of this configuration lanyard, CS is committed to the safety of every worker at height using our products and we are determined to resolve any potential for inadvertent disconnection to occur for the reason described above.

Capital Safety has determined that the appropriate solution to the identified issue is a combination of (a) an alternate snaphook and (b) a single lanyard connection to the eye of the snaphook. Accordingly, we have engineered a new version of the affected lanyards to take into account what we have learned about the combination of components on the Protecta shock-absorbing lanyards.

If you have a Protecta Pro Stretch or Pro Stop lanyard manufactured before November 1, 2011 in service (as identified by part numbers above), you should immediately take the lanyard out of service and call our Customer Service department at 800-328-6146 (prompt #1) to obtain a "QA" number for the return of the lanyard and to be provided with a new Protecta lanyard at Capital Safety's expense. The free lanyard applies only if the returned lanyard is in proper working condition as determined by Capital Safety; if not, charges may apply.
