Safety Alert: Hydraulic Hoist Cylinder Failure on Komatsu 680-E Trucks

EQUIPMENT: All 445E, 510E, 630E, AND 685E HAULPAK® Trucks with "Super Cylinder" Hoist Cylinders

SUBJECT: Product Improvements to Hoist Cylinders

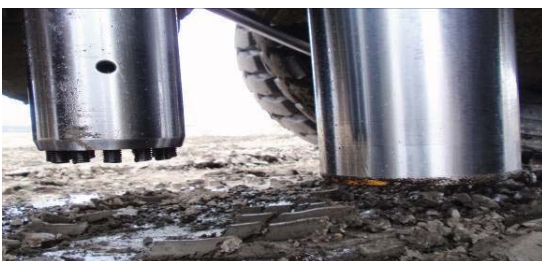
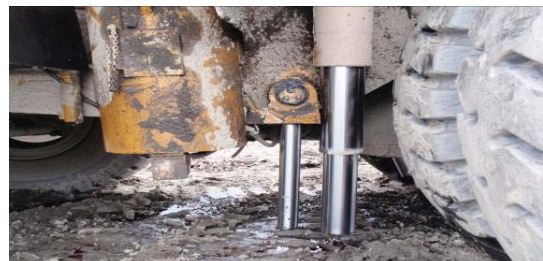
A Komatsu 685-E haul truck was operating at a surface coal mine when the bolts for the third stage piston bearing retainer from both Hoist Cylinders failed, allowing the dump bed to fall abruptly onto the frame of the truck. The truck operator was not injured; however the operator withstood a severe jolt. The Komatsu truck utilizes a hoist limit switch intended to stop the cylinders from full extension. However, it was determined that this switch was not properly maintained and allowed the cylinders to extend beyond their normal limit. When the cylinders extended to the maximum travel, a “slide hammer” effect occurred between the piston and barrel head, causing repeated jolts. This condition most likely stressed the bolts and caused the failure over the dump cycles. Upon inspection of the two hoist cylinders, it was determined that one of the cylinders had six (6) bolts that held the retainer and the other cylinder had twelve (12) bolts.

Hoist Cylinder Failure

A Haulpak service bulletin, number 529, Section L (18 March'94) was issued for the 685E truck that provided for a Hoist Cylinder Rework Kit, MK3567. This kit provided parts and instructions for improving the method of retaining the third stage piston bearing retainer. The rework kit uses 12 - 5/8” UNRC grade 9, 12-point capscrews, and a single, hardened washer plate. Even though this rework kit has been available for years, it appears that 6-bolt cylinders are still in service. As in this case, the hoist cylinders on the truck were mismatched with different bolts in the cylinders. This mismatch may have contributed to the failure. It is recommended that maintenance records for the hoist cylinders be reviewed or that the cylinders be inspected to ensure that both cylinders have the twelve bolt modification. In addition, mines should inspect the hoist limit switch to make sure it is properly adjusted and working. Mine operators should discuss this situation with their maintenance departments, truck operators, and their cylinder rebuild shops. Mines should not accept rebuilt cylinders that have the 6-bolt design. Mine operators should also determine if truck operators are experiencing occurrences where the hoist cylinders are extending to the maximum limit. This may be detected by the operator feeling a hard jolt when the truck is dumping or a change in the sound of the hydraulic pump when the cylinders are fully extended.

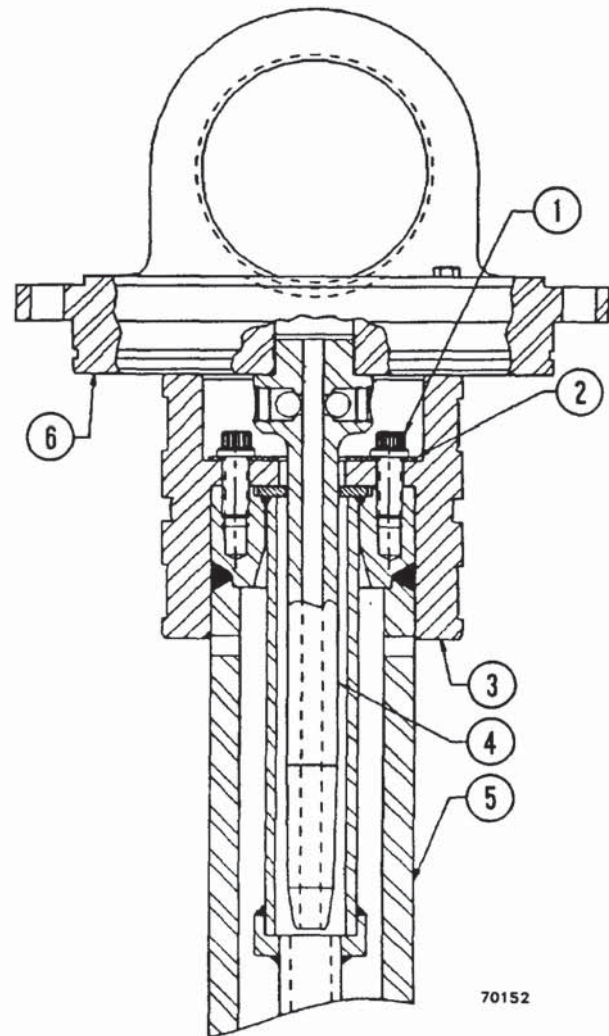
FIGURE 1. CYLINDER, 3rd STAGE

The Hoist Cylinder Rework Kits, MK3567 for the 630E and 685E and MK3569 for the 445E and 510E, provide the parts and instructions for improving the method of retaining the third stage piston bearing retainer. On existing cylinders, the retainer is held by six 5/8" UNC grade 8 hex head capscrews with hardened flat washers. The new method uses twelve 5/8" UNRC grade 9, twelve point capscrews (1, Figure 1) and a single, hardened washer plate (2). This provides a significant increase in the clamping force exerted on the piston bearing retainer (3).

When a cylinder is disassembled, the Rod Eye Structure (5) should be modified according to rework drawing ED5217 for the 630E/685E or ED5201 for the 445E/510E which adds six more tapped holes. When reworking the Rod Eye Structure, plug all external piston openings to prevent internal contamination. A new bearing retainer ED5224 will be required (3). The quill assembly (4) must be removed from the cylinder head (6) and chamfered as shown on rework drawing ED5219. After modification, the following parts should be renumbered with the same part numbers as used in the production cylinders, but with a prefix "R" in front of the number to indicate a reworked part.

1. Make certain threads on capscrews and threads in rod eye structure are clean and dry (free of oil and solvent).
2. Using Loctite 'LOCQUIC' Primer "T" (TL8753, or equivalent), spray mating threads on capscrews and threads in rod eye structure.

3. Apply Loctite Sealant #277 (VJ6863, or equivalent) to mating threads of both capscrews and threads in the rod eye structure.
4. Install capscrews (1, Figure 4) and hardened washer plate (2) and tighten capscrews to 250 ft. lbs. (209 N.m) torque.

Allow parts to cure for 2* hours before exposing threaded areas to oil

The rod eye structure should be checked using non destructive testing procedures before reworking. Cracks or other defects may require replacement. The new part(s) can be ordered using the part numbers shown in the reworked column but omitting the "R".

However, if a truck has experienced a failure of the third stage piston bearing retainer/rod eye structure, the opposite cylinder may also have been overstressed, and should be checked for broken or stretched bolts in the 3rd stage piston area. Such damage would require BOTH cylinders to be repaired and/or reworked to the new configuration.
