SAFETY BULLETIN

Drill rig operator sustains a serious hand injury

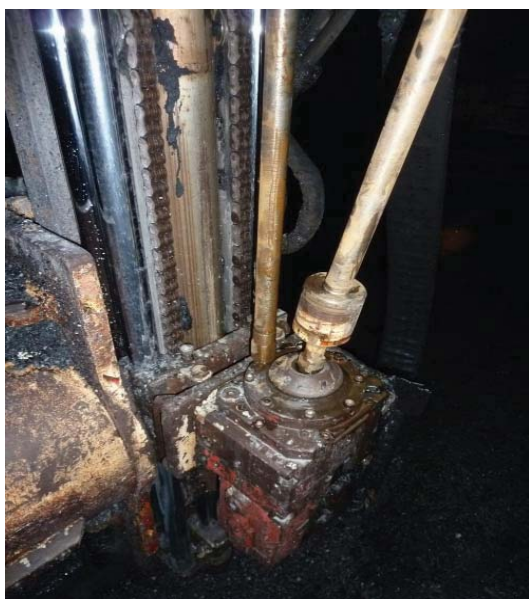
Failure of the gripper jaws to support the drill string leads to a serious hand injury

- 1) Consideration should be given to complying with the relevant parts of the AS 4024.1-2006 'Safety of machinery' series of standards and MDG 35.1 *Bolting and drilling plant in mines*.

In particular AS 4024.1601-2006 'Design of controls, interlocks and guarding—Two-hand control devices—Functional aspects and design principles' provides specific guidance on the prevention of accidental activation and accidental defeat of controls.

- 2) Design and operational risk assessments should consider human error analysis on the particular plant in an attempt to highlight errors in design which could lead to inadvertent activation of a function that has the potential for an injury or incident.
- 3) Operational risk assessments for strata drilling equipment should be reviewed to ensure they address all the risks associated with your particular drilling process or processes.

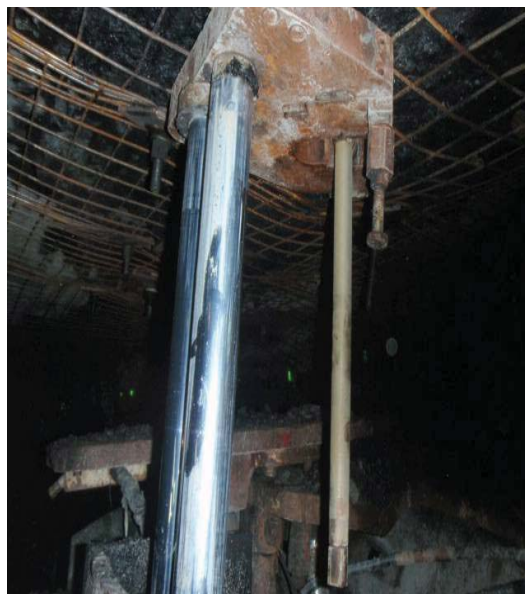
It appears the operator placed his right hand over the drill chuck and attempted to activate the water valve located on the control station. The operator inadvertently operated the gripper jaws release control lever which is located directly above the water control valve. This allowed the drill string to fall from the hole severing the operator's finger.

The control handle for both gripper jaws and water flushing are fitted with the same style handle and the movement of the flushing water 'on' control and gripper release control are in the same direction, which can lead to confusion and potential human error.

Inadvertent operation of the gripper jaw controls leads to a serious hand injury
