# SAFETY BULLETIN

## Failure of explosion-protection characteristics of flameproof equipment

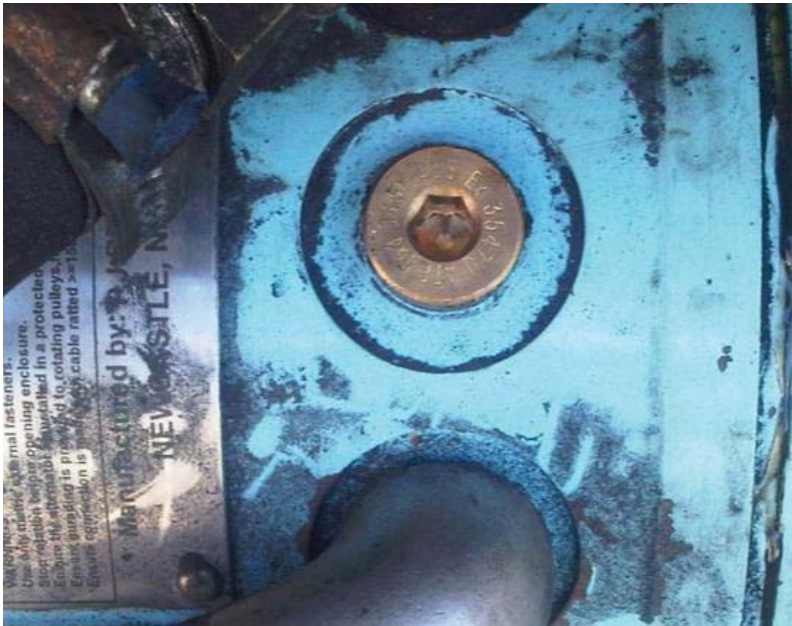
During a routine inspection, the flameproof alternator of a diesel powered personnel transport vehicle was found to be fitted with a plastic blanking plug in an unused gland entry of the alternator. The alternator had been in service for several months prior to identification of this defect.

The alternator was overhauled at a licensed facility for the repair and overhaul of electrical Ex apparatus. It was routine practice at the licensed facility to fit plastic blanking plugs in all threaded gland entry holes of new and repaired alternators prior to painting to prevent ingress of dirt or water during delivery to a customer. The alternators are subsequently supplied to mines with the plastic blanking plugs still fitted.

The alternator was installed on the vehicle as an in-service replacement by mine site personnel and had been in use for several months in a non-Ex condition. The unused gland entry was overlooked during installation at the mine, and by subsequent scheduled examinations.

Photo shows a certified blanking plug in the unused entry hole.

- Mine operators should implement purchase and supply processes that require all unused cable entries on Ex electrical equipment be fitted with certified blanking elements prior to the supply of the equipment to the mine.
- Suppliers of Ex electrical plant and equipment should only supply Ex electrical plant and equipment with all unused gland entries fitted with suitably certified blanking elements.
- Safety alerts SA04-23 '*Unsafe Flameproof Enclosure*' and SA05-02 '*Unsafe Flameproof Enclosure – Overhauled Auxiliary Fan*' should also be reviewed.

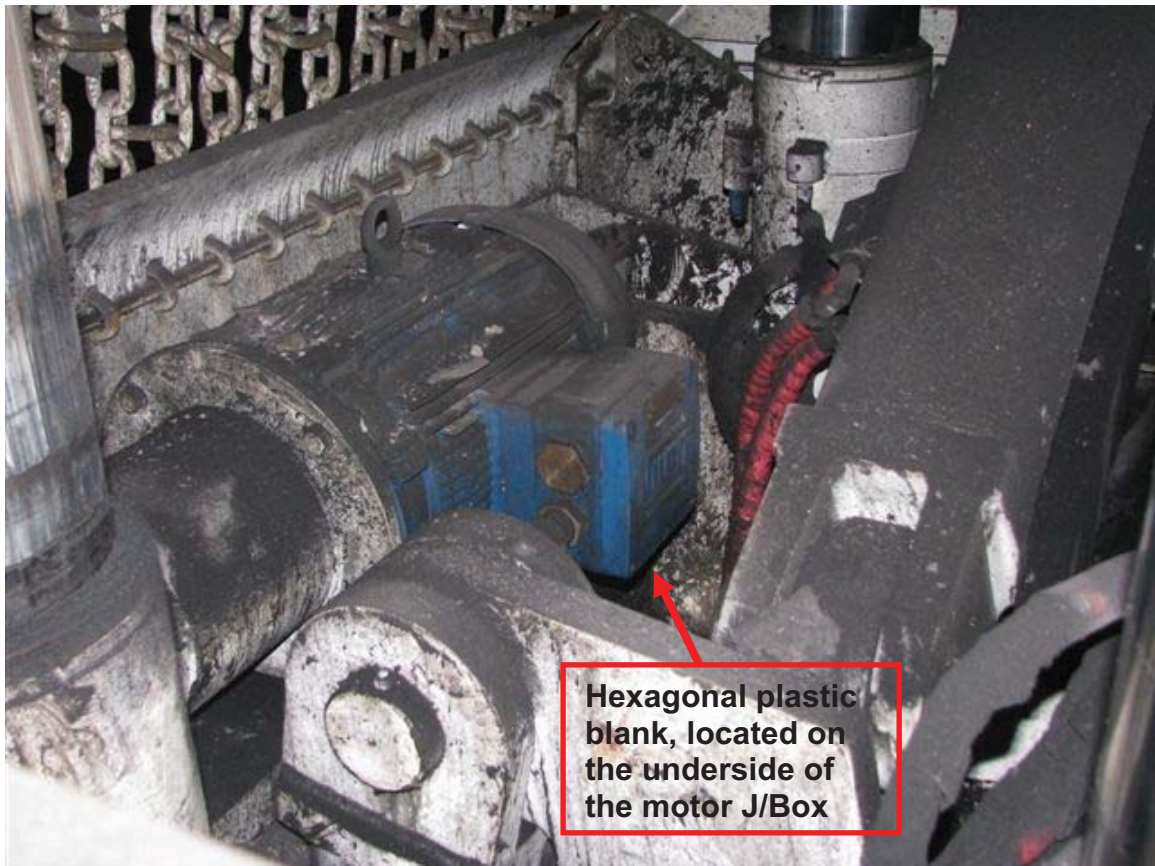
Photo of BLS Motor J/Box

During the replacement of a flameproof motor on a BLS an electrician identified that the newly supplied motor had been fitted with a plastic, non-Ex hexagonal-headed blanking plug. The plastic plug was located on the underside of the motor junction box and had been painted the colour of the motor. This motor was new but had been rewound from 415 to 1000 volts by the motor repair workshop prior to being installed.

The electrician subsequently inspected another BLS that was in service. The in-service BLS had previously been fitted with a replacement motor by a licensed overhaul workshop before delivery to the mine site. The BLS had been in service for 4 weeks within the hazardous zone with Code A inspections being undertaken daily. This motor was also found to be fitted with a plastic hexagonal-headed blanking plug on the bottom side of the motor junction box.

The original motor had been replaced by a licensed electrical workshop prior to the BLS being returned to site. The motor had been fitted by a fourth year apprentice and the paperwork signed off by a tradesman that had not inspected the installation.

The mine had inspected the BLS under the sites 'introduction to site' management system prior to the BLS being placed into service. The inspections which include an internal inspection failed to identify the non-flameproof plastic plug. Several external visual inspections had also failed to identify the plastic plug.

- Mines should review their systems for the introduction of equipment to site and for in-service maintenance activities for electrical equipment and plant. This review should ensure the requirements of Australian Standard AS/NZS 2290.1 '*Electrical equipment for coal mines – Introduction and maintenance*' have been addressed, including requirements for the inspection of Ex areas and component parts that are not readily accessible.
- Training systems for personnel that undertake work on Ex equipment at the mine should be reviewed to ensure periodic review of the competency and standards of workmanship of these personnel.
