Safety Alert

Mines Inspectorate—Underground metalliferous mines

Safety Alert No. 280 | 18 January 2012

Emergency refuge bay explosion

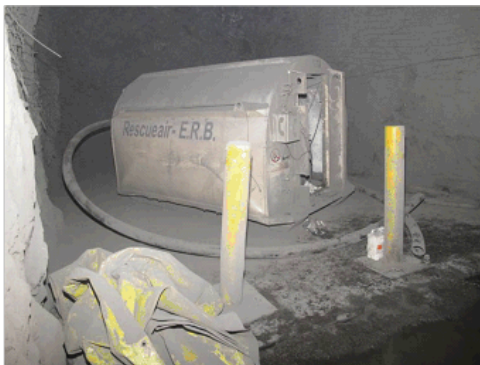
A periodic inspection of an underground Rescueair emergency refuge bay (ERB) found that an explosion had occurred inside. It is believed that an explosive atmosphere was created by the hydrogen generated when the EverExceed® VRLA (Valve Regulated Lead Acid) batteries were overcharged.

Outside of the ERB after the incident

1. Inspect all ERB battery and battery-charging systems to ensure that they are compatible with, and installed and operating within, OEM specifications.
2. Ensure that all ERBs are subject to scheduled inspection and maintenance by suitably qualified personnel, covering OEM specifications as a minimum.
3. Regularly inspect batteries for signs of gasification (swelling) or other defects such as cracking of cases and deterioration of terminations.
4. Relocate batteries to a place where flammable gases cannot accumulate.
5. Use batteries that do not expel hydrogen in the event of overcharging.
6. Install battery cell monitors on each battery to ensure that the internal impedance of the battery is within acceptable limits. Where a defect is detected, initiate an alarm.

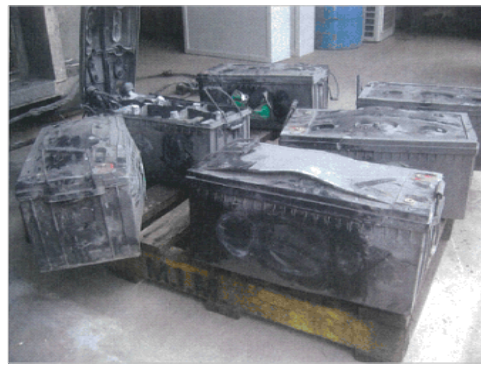
Batteries from the ERB

- EverExceed® battery-charging system did not switch off when manufacturer's fully charged battery voltage was reached.
- Overcharging the batteries produced hydrogen which, in this case, vented into the ERB.
- Location of batteries inside the ERB.
- ERB inspection procedure was not followed correctly by personnel.
- Gas was ignited by an unknown energy source. Flammable limits of hydrogen in air are 4 to 74% by volume.

The batteries were housed under a seat within the ERB. The gas expelled from the overcharged batteries was circulated around the airtight ERB by the air-conditioning unit. While the ignition source hasn't been positively identified, the battery charger is suspected. Other potential ignition sources inside the ERB include lights, two-way radio and an air conditioner.
