# Safety Alert

Safety Alert No. 283 | 18 January 2012

## Screenbox flywheel failures on Powerscreen® Chieftain 2-deck screening plants

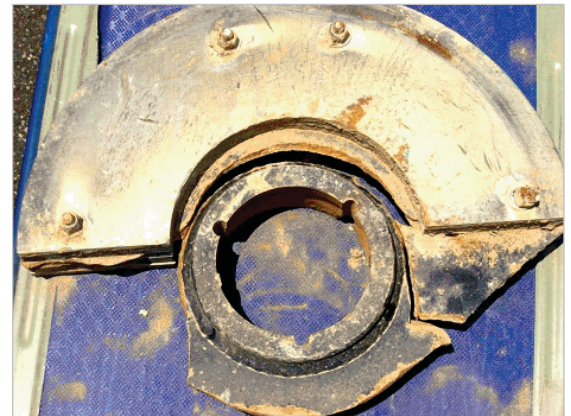
In three separate incidents, the screenbox flywheel on Chieftain 2-deck screening plants failed. Two incidents occurred on a Chieftain 2100 flywheel (damaged flywheel pictured) and one on a Chieftain 1400.

All three failures exhibited a similar pattern in that the flywheels separated from the hub adjacent to the weld.

The weight of the Chieftain 2100 detached flywheel, with its complement of six counterweights, is in excess of 50 kg. In one incident the disintegrated flywheel landed on the ground underneath the access platform, placing any person in the vicinity at risk. It is not known if the flywheel guard has been designed to contain a disintegrating flywheel.

Powerscreen has issued a Safety Notice CB 028 that recommends all flywheels on the Warrior WR1800 should be replaced with heavier duty units. It is believed that the flywheels for the Chieftain 2100 are the same as the lighter duty Warrior WR1800 flywheels.

1. Owners and operators of Powerscreen® Chieftain 2100 and Chieftain 1400 2-deck screening plants should contact Lincom Pacific Equipment Pty Ltd to ascertain what action to take so that injury risk due to a failure of screenbox flywheels is within acceptable limits and as low as reasonably achievable.
2. Keep guards in place while the plant is under operation, testing or fault finding.
3. Ensure workers' safety in the flywheel drop zone should a flywheel fail in service and detach.
