Significant Incident Report

Mines Inspectorate

Significant incident report no. 77
12 May 2011

Opal miner dies from engulfment in mullock

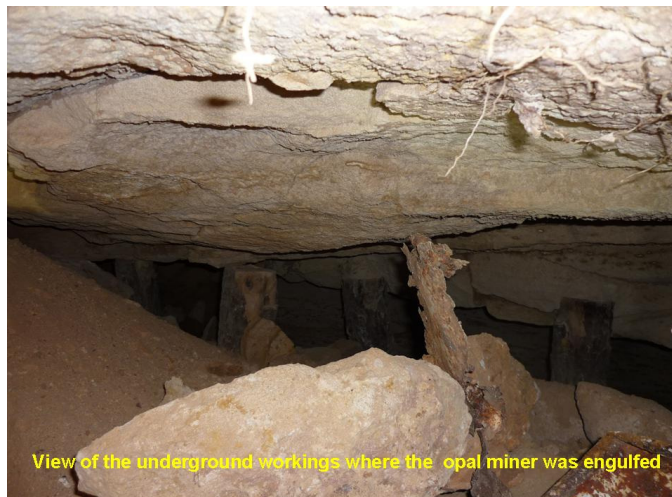
Cause: Removing material from the bottom of the mullock pile caused the angle of the pile to steepen. As more material was removed, the pile, unable to support the weight of mullock backfilling the shaft, collapsed and flowed into the workings.

- The backfilled shaft mullock pile in the 1.2 m high workings was close to the bottom of the miner's access shaft. It was composed of loose, unconsolidated, dry and fine rock. A small heap of mullock had accumulated between the working miner and the bottom of the access shaft, reducing the height of the workings there and partially blocking his access and retreat.

- The workings were supported by original timber props installed when they were mined about 80 years ago. A number of large rocks had fallen from the sandstone roof and were lying on the mullock pile and on the floor of the workings, indicating that the ground support was inadequate.

View of the underground workings where the opal miner was engulfed

1. Be aware of the location of any backfilled shafts that may intersect your workings as a result of your mining activities and record the location on your mine plan.

2. Do not disturb backfilled shafts in underground opal mine workings using hand-mining methods.
3. Do not disturb backfilled shafts in underground opal mine workings using mechanical excavation equipment without first conducting a risk assessment and implementing appropriated risk control measures to guard against the engulfment hazard.

4. Install appropriate ground support to prevent rock falls from the roof.
5. Ensure adequate lighting is provided and maintained to enable you to see what you are doing and to monitor any change in the underground conditions.
