INCIDENT ALERT

LOCATION:	CEMENT	ALERT STATUS:	Normal
ACTIVITY:	TRANSPORT / DELIVERY	DATE ISSUED:	25/06/2011
SUB ACTIVITY:	PRODUCT DELIVERY	INCIDENT No:	00290

Fall from Tipper

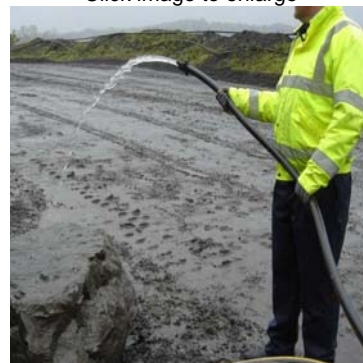
Picture 1: Pump Inoperative

On inspection, the water pressure at the wash station was not sufficient to allow the 'jet' of water to reach the full length of a tipper (Picture No:1) and this may have been the reason why the wash station was not used. Further investigation found that the wash station booster pump had tripped, once reset the station operated as intended (picture No:2).

The supervision and control of contractors is paramount and where local rules are in place they must be enforced and policed at all times. All equipment must be suitable & sufficient for the task that it is intended.

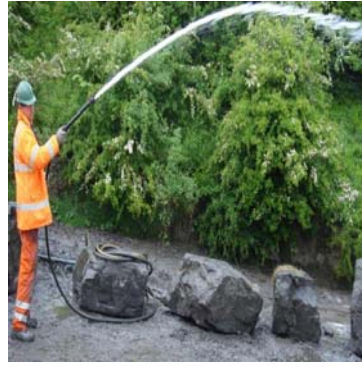
Picture 2: Pump Working
