INCIDENT ALERT

ALERT STATUS: Normal
DATE ISSUED: 04/04/2011
INCIDENT No: 00287

Excavator Crush

Groundworker trapped by excavator.

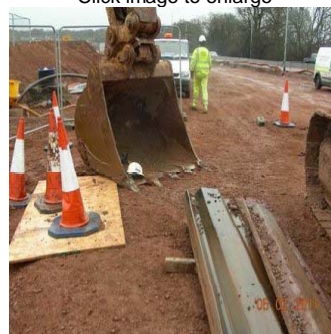
Bucket

An incident occurred recently within one of our group companies where a groundworker was trapped between the bucket and the track of a 35 tonne excavator. The operative was trapped just below the left knee, and tragically after multiple operations had to have his lower left leg amputated.

The principal causal factor was when the plant driver was climbing back into his cab following a conversation with the injured person, his coat snagged the slew/dipper arm control, and without realising that his coat was caught, he activated the "dead mans handle".

The excavator was 'ticking over' in idle mode, as he climbed in but the machine was set in 'high revs'. This deactivation of the safety device caused the machine bucket to travel at high speed in the direction dictated by the snagged control lever.

At that very moment the IP was walking between the bucket and track of the machine. This was so he could continue a conversation with a third party who had arrived at the scene just before the incident, he became trapped between the bucket and the track.

Plant must be turned off when the operator exits the cab.

Managers of plant operations should review the start up procedures of plant items, in particular, thought should be given to a methodical approach to the start up of plant, this will allow the operator time to ensure the hazard area of the plant is clear of persons on the ground. Engaging 'low revs' would be part of this process.

Segregation of all pedestrians and plant must be reviewed.

Tool Box Talks, task briefings, STARRT talks or any work related conversations should be undertaken away from plant items in a safe place.
