## INCIDENT ALERT

LOCATION:	CEMENT	ALERT STATUS:	Normal
ACTIVITY:	MAINTENANCE & HOUSEKEEPING	DATE ISSUED:	17/03/2011
SUB ACTIVITY:	N/A	INCIDENT No:	00285

#### Bolt Tensioner Incident

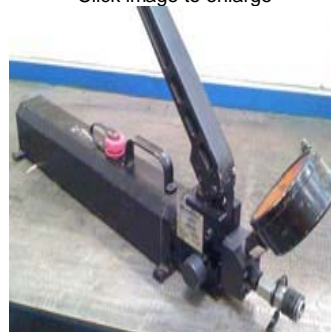
Bolt Tensioner

A bolt tensioner pressurised to 2000bar suddenly discharged hydraulic fluid that injected into the armpit of a contractor using the equipment on a cement mill gearbox..

The primary cause of the incident was that the bolt tensioner had been previously over extended. The yellow band indicates the maximum extension of the inner ram, and this had been exceeded whilst in use. Over extending the unit can result in the seal, which is completely concealed, failing to function correctly. Normally seepage of hydraulic fluid would be expected; however, as occurred in this case a sudden high pressure fluid discharge can occur with potentially serious injuries. The jet discharged between the inner and outer parts of the unit.

- Over extending the inner ram (which may be indicated by a yellow band – as in this incident) or a red band can result in loss of an effective seal.
- Over extension followed by subsequent retraction of the unit may affect the seal, but this will not be obvious from an external examination.

- When in use the inner ram must be completely wound back so that the indicator band is fully retracted, failure to do so is likely to result in over extension whilst in use.

- The operator must be fully conversant with the limitations of this type of bolt tensioner as the action of the user is critical to the safe use of the equipment.

- The maximum extension of the inner ram should be specified by the manufacturer; in this case it was 8mm, it essential that this is not exceeded.
- Bolt tensioners manufactured since about 2007 have a fail safe pressure relief system fitted that prevents over extension of the inner ram.
