INCIDENT ALERT

LOCATION:	QUARRY	ALERT STATUS:	Normal
ACTIVITY:	PRODUCTION AND PROCESSING	DATE ISSUED:	05/07/2011
SUB ACTIVITY:	AGGREGATE PROCESSING	INCIDENT No:	00291

Chassis Failure Komatsu 350 Dumper

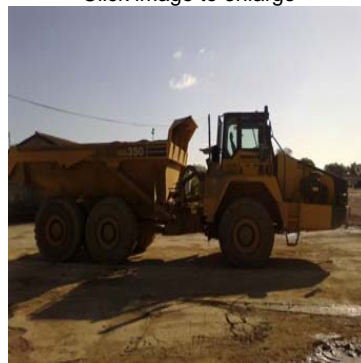
Plant

An inspection of the dumper was undertaken and it was discovered that the near-side tractor unit chassis had a large split running through it. This made the vehicle un-safe and it was immediately taken out of service.

- Pressure wash and conduct a thorough chassis inspection of all Komatsu HM 350 and HM400 dumpers.
- A known indicator of this problem is a widening of the gap where the battery box abuts the wheel arch.
- Where there is any doubt contact John Taylor, Product Support Manager at Marubeni Komatsu, who will arrange for a service engineer visit. (Editors note: Other company's may need to make their own arrangements for a specialist inspection).

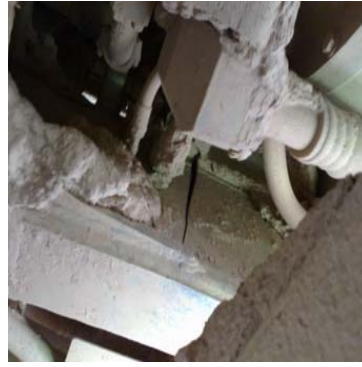
Split Chassis
