INCIDENT ALERT

LOCATION:	MOBILE PLANT	ALERT STATUS:	Normal
ACTIVITY:	ACCESS & EGRESS & WORKING AT HEIGHT	DATE ISSUED:	11/08/2011
SUB ACTIVITY:	N/A	INCIDENT No:	00294

Fall from mobile plant

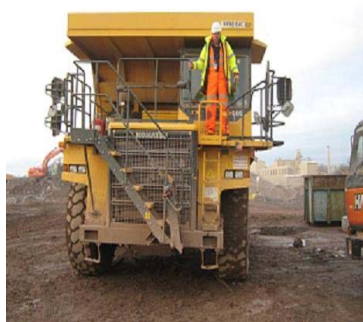
An employee suffered a fracture to his arm after falling 3 metres from his vehicle whilst attempting to descend via the emergency exit ladder. The normal means of access and egress was by a stairway with a retractable bottom section, due to mechanical problems this was not working. Investigation identified that the fault with the normal access route had been unresolved for some time and it had become normal practice to use the emergency route. The gate at the top of the emergency ladder was also faulty with the catch not properly aligned causing difficulty when releasing it. It was whilst trying to release this catch that the employee apparently fell, toppling over the gate and falling to the ground. Other factors identified were that the employee may have been carrying a plastic container at the time and would have been unable to maintain 3 points of contact.

Driver fell from top of emergency exit ladder

The dumper was fitted with a modern access stairway which due to a fault was out of use. Whilst alternative access was identified via the emergency exit the risks from this were not fully identified. The alternative arrangements should only have been a short term solution in fact were allowed to persist for several months.

Get a Grip – Is everyone aware of the need for 3 points of contact when using steps and ladders? Is it common practice or only when being watched? Are discrete observations made to ensure that it is an ingrained behaviour?

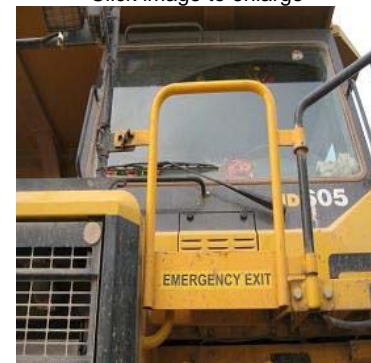
Close up of gate at top of emergency exit ladder
