INCIDENT ALERT

LOCATION:	AGGREGATE DREDGER	ALERT STATUS:	Normal
ACTIVITY:	ACCESS & EGRESS & WORKING AT HEIGHT	DATE ISSUED:	16/01/2012
SUB ACTIVITY:	N/A	INCIDENT No:	00321

Fall into Unguarded Opening

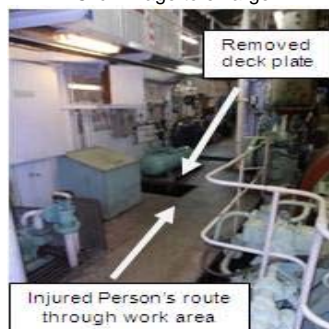
A ships Engineer was fault finding on the main engine, an activity that required a deck plate to be lifted. Two contractors were working nearby and another Engineer (the Injured Person, IP) was working on the other side of the engine room.

The Engineer who was fault finding briefly went below the removed deck plate to trace an air line. The Injured Person, who had completed his task, was returning his tools to the engine room workshop, via the area where the deck plate had been removed.

The Engineer who had been below the plates for about a minute then climbed out and turned to see the IP carrying the tools approaching him and the unguarded opening in the deck. The Engineer immediately challenged the approaching IP by putting his hand up to warn / stop him from proceeding towards the hazardous location where the plate had been removed (Note: ear protection was being worn in the engine room).

Unfortunately the IP failed to acknowledge the warning, as he was not looking where he was going, and subsequently stepped into the unguarded opening, falling to the deck; he did manage to stop himself from falling completely into the opening. This resulted in the IP requiring hospital treatment, where he was treated for fractures to his lower right leg and cuts and bruising to his left leg and arm.

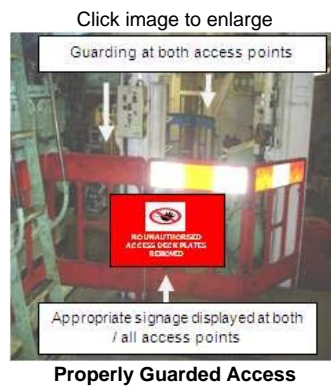
- While the Engineer was only under the plates for a very short period and did not leave the work location, he failed to look after himself and his colleagues by effectively physically guarding the work area and having the appropriate signage in place warning of the hazards at that location (E.G. "NO UNAUTHORISED ACCESS - FLOORING REMOVED").
- The contractors working alongside did not challenge the Engineer when he removed the deck plate about the lack of guarding around the opening.
- The Injured Person knowingly went into a work area when there was another alternative safe route available.
- The Injured Person wasn't looking where he was going when he was transiting the known work area.

This incident demonstrates the importance of always putting physical barriers / guarding in place, with appropriate warning signage, prior to any plates, gratings or covers etc. being removed where there is a potential risk of falling into an unprotected opening, even for short periods.
