## INCIDENT ALERT

LOCATION:	QUARRY	ALERT STATUS:	Normal
ACTIVITY:	MAINTENANCE & HOUSEKEEPING	DATE ISSUED:	12/08/2011
SUB ACTIVITY:	N/A	INCIDENT No:	00295

### Faulty Isolator Handle

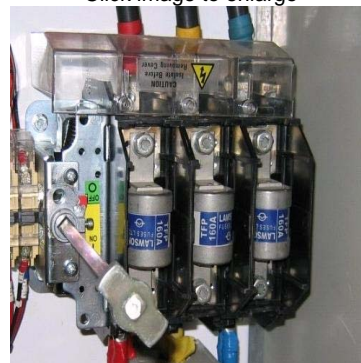
The manager turned off the isolator handle on the Fuse Combination Unit (FCU), (A typical FCU is shown in Photo No 1 below) this released the mechanical interlock allowing the cabinet to open.

On opening the 'failed' FCU it was found that the rocker 'cam' had sheared on two of the three phases leaving the incoming sliding in the closed position bridging the contact terminals allowing power to flow through the fuses.

There were no physical indications on the FCU to suggest that there was a problem of this magnitude.

Example of FCU

The FCU was replaced by a competent electrical contractor.

The Lock-Off and Isolation Procedures throughout the company must be amended to include testing every time that access is required inside a panel (to, for example, replace fuses or reset trips): to ensure that all parts to be handled are de-energised. The isolator handle cannot always be trusted to do this.
