INCIDENT ALERT

Normal
02/12/2011
00317

Fire: flammable substance close to oxy-propane cutting activity

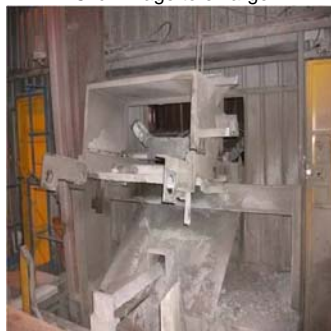
A conveyor was to be removed from the location where it was situated and was to be subsequently relocated in a new position. As part of the dismantling process, a canopy needed to be removed. The maintenance engineer utilised oxy-Propane cutting equipment to cut the canopy away from the conveyor structure.

- Before any hot work assess the area for potentially flammable substances.
- Conduct a suitable and sufficient risk assessment.
- Complete a permit to work appropriate to the task.
- Ensure you have an effective escape route available to you.
