INCIDENT ALERT

LOCATION:	ASPHALT/COATING PLANT	ALERT STATUS:	Normal
ACTIVITY:	TRANSPORT / DELIVERY	DATE ISSUED:	22/12/2010
SUB ACTIVITY:	PRODUCT DELIVERY	INCIDENT No:	00280

Tanker Driver gets Tackcoat in eye

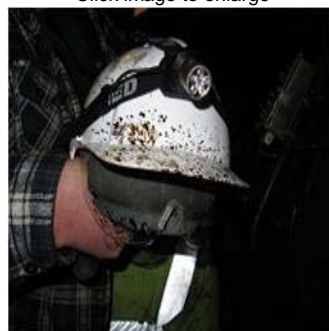
Helmet

As he was checking an area behind the cab he was sprayed with Tackcoat which hit his helmet and bottom part of his visor, the rest being shielded by the peak of his helmet. However, a small amount managed to trickle into the corner of his eye. The driver washed his eye with eye wash. He later attended his local hospital where he was treated with eye drops as a precaution, though after this he could not then drive for 24 hours.

The driver did not have a current risk assessment for this task and had not carried out the company's 'Take 1 risk assessment'; had this been done he could have been wearing more suitable eye protection. Had he not been wearing his visor the injuries sustained could have been far worse.

ALWAYS WEAR THE CORRECT PPE – Where there is a substance being sprayed or there is a leak; a full face visor is considered to be more suitable and should be carried by all tackcoat sprayers and tackcoat tanker drivers.

(Editors note: this could also be covered as part of the driver's training and possibly similar hoses should be checked for wear).
