# WEEKLY INCIDENT SUMMARY

Week ending Friday 24 April 2020

This incident summary provides information on reportable incidents and safety advice for the NSW mining industry. To report an incident to the NSW Resources Regulator: phone 1300 814 609 24 hours a day, 7 days a week.

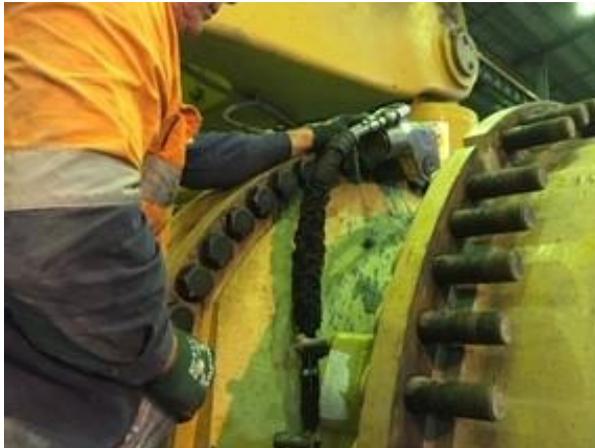
INCIDENT TYPE	SUMMARY	RECOMMENDATIONS TO INDUSTRY
Dangerous incident IncNot0037197 Open cut coal mine	<p>A fitter suffered an electric shock while using a Hytorc unit to torque bolts on the chassis of a truck.</p> <p>At the same time, a welder was carrying out air arc gouging on the truck.</p> <p>A mine investigation showed that air arc gouging generates an induced voltage into the frame of the truck.</p>	<p>When undertaking welding activities on truck bodies in a workshop, an earth bond cable should be installed between the truck body and the building earth. It is also recommended that when air arc gouging is being undertaken on truck bodies, no other tasks involving contact with the truck should be undertaken simultaneously.</p>

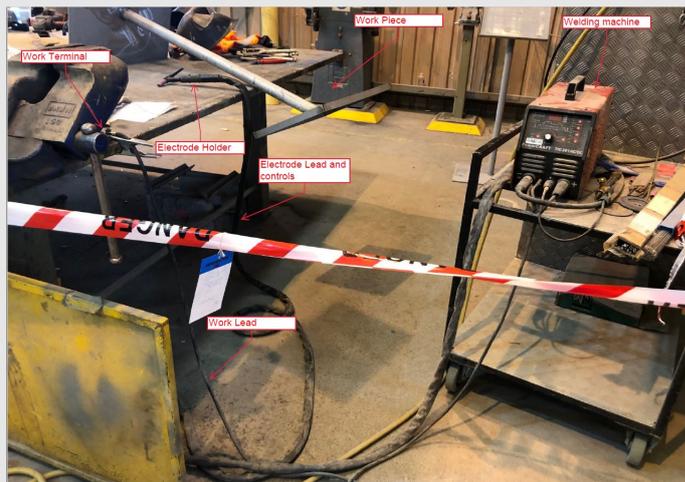
Dangerous Incident  
IncNot0037201  
Metals mine processing plant

A boilermaker suffered an electric shock while operating a 15A TIG welder in a surface hot work area. The electric shock occurred when the worker made contact with the welder electrode.

A preliminary investigation showed that the output voltage of the welder was 130 VDC while the nameplate output was 68 VDC. This suggested a potential internal fault.

Also, the operator was in contact with the electrode and metallic workbench with a suspected hand-to-hand current path.

All welding equipment should be inspected before use and should be properly maintained.

Workers involved with welding activities should remain insulated from the welding job. Welding gloves are not electrical insulators and if they are damp, they can enhance the effect of an electric shock.
