WEEKLY INCIDENT SUMMARY

Week ending Friday 18 September 2020

Mine safety reference ISR20-38

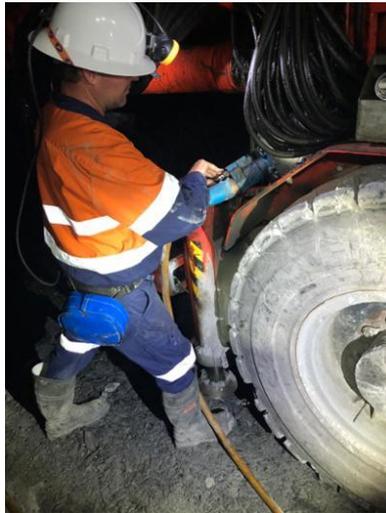
| INCIDENT TYPE | SUMMARY | COMMENTS TO INDUSTRY |
|--|--|--|
| Dangerous incident IncNot0038233 Underground metals mine | A jumbo offsider sustained a serious crush injury to his foot when it was caught beneath a stabilising jack that was being lowered. The offsider was preparing to plug a pump cable into a cable receptacle on the jumbo while the stabilising jacks were being lowered. | Work procedures and controls must consider the risk of workers being in proximity to equipment. No-go zones and safe standing zones for workers should be implemented and communicated to all workers involved in the operation of plant. The use of proximity detection should be considered when completing risk assessments for working around operating equipment. |

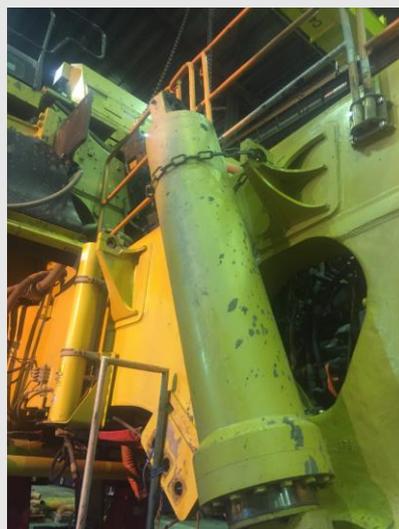
Dangerous
incident
IncNot0038244
Open cut coal
mine

An electrical tradesman had his head caught between a lift cylinder and the body of a haul truck. The tradesman was disconnecting an earth strap adjacent to POS34. The tray of the truck had been removed and the lift cylinder was chained to a lug. As the tradesman reached to disconnect the earth strap, the lift cylinder pivoted and pinned the tradesman against the truck. He sustained minor head injuries.

While the lift cylinder had been chained to a lug, there was enough slack in the chain to allow the cylinder to move when bumped.

Unintended movement of secured loads is an identifiable risk. Safe work procedures should clearly articulate the risk and outline the controls required to prevent unintended movement.

Mine operators should ensure that their work procedures for this common task include this particular risk and the necessary controls.

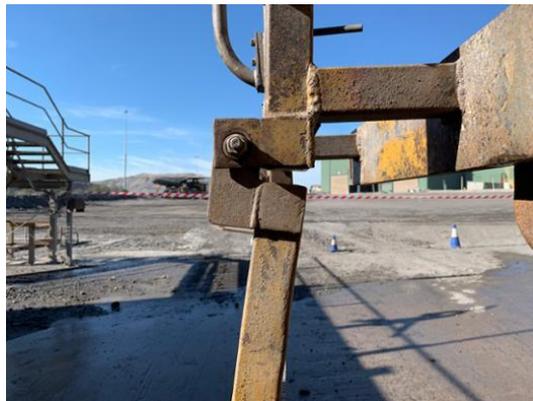
Dangerous
incident
IncNot0038271
Open cut coal
mine

A worker's index finger was severely crushed in the pivot point of a haul truck's emergency egress ladder. The truck was being washed down and the egress ladder was activated to allow access to air filter dust caps. The operator put his hands on the rails of the ladder to climb up, but when he put his weight on the bottom step the ladder closed at the pivot point where he had his hand crushing his finger.

Mine operators should review their procedures to determine if their training includes the hazards associated with potential pinch points and their identification. Mine operators should consider reviewing the emergency egress handrail design in consultation with the OEM.

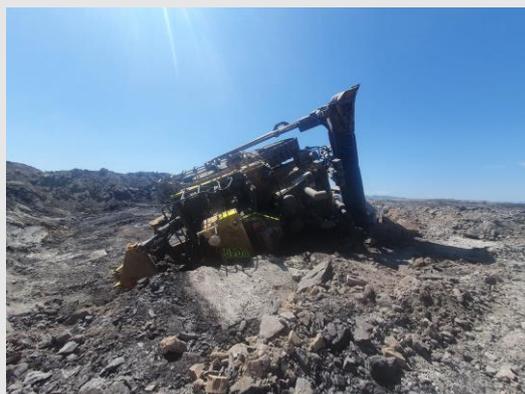
Dangerous
incident
IncNot0038274
Open cut coal
mine

A dozer tipped over when the operator drove the left-side track partially up a pile of side casted material. The dozer became unbalanced and slowly tipped onto its right-side track. The operator was able to exit the dozer and was uninjured.

Equipment operators must maintain situational awareness and remain vigilant to manage the risk of machine rollovers. When planning tasks and travel paths, supervisors must consider rollover hazards.

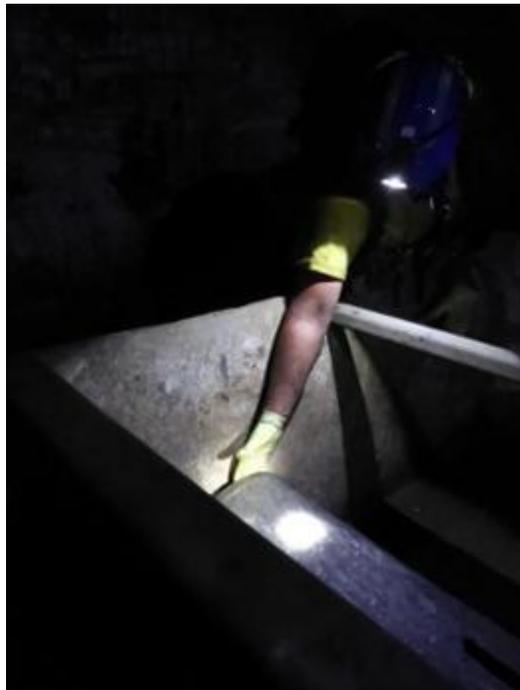
Dangerous
incident
IncNot0038285
Underground
coal mine

A mine worker severed the tip of one finger and received deep cuts to other fingers of his right hand while sliding an auger sleeve into an empty kibble. He and another worker were attempting to get the auger sleeve into the kibble, which had a cross brace on the top, making it awkward to manoeuvre. One worker lifted the auger sleeve to attempt to slide it under the cross brace and the other worker had his hand at the back of the auger sleeve to guide it into place. When one worker pushed the auger sleeve it slipped quickly off the top of the kibble crushing the other worker's hand between the auger sleeve and the kibble wall.

Workers must be trained to identify potential hazards when undertaking unplanned tasks and be capable of assessing and controlling risks. Communication between workers jointly undertaking tasks is of paramount importance and the approach to any unplanned task should be discussed and agreed upon.
