# WEEKLY INCIDENT SUMMARY

Week ending Friday 07 Feb 2020

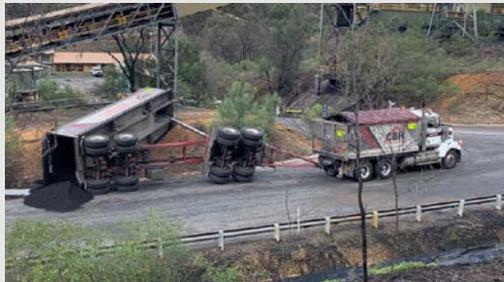
Dangerous  
Incident  
IncNot0036686  
Underground  
coal mine

A six-wheel tipper truck towing an axle trailer was tipping a load when the axle trailer tipped onto its side. The truck was unable to tip at the unloading area because of weather conditions. The operator was asked to tip on a bitumen roadway instead. No-one was injured or was in the area at the time of this incident.

The stability of articulated vehicles is a known risk, and mines should manage this. Consideration should be given to factors including:

- operating grades
- uneven surfaces (holes, rocks, foreign material)
- tipping loads
- loads hang-up
- load movement
- operations speeds.
