Truck driver crushed by excavator bucket

28 September 2020

Incident Information Release

SAFEWORK NSW

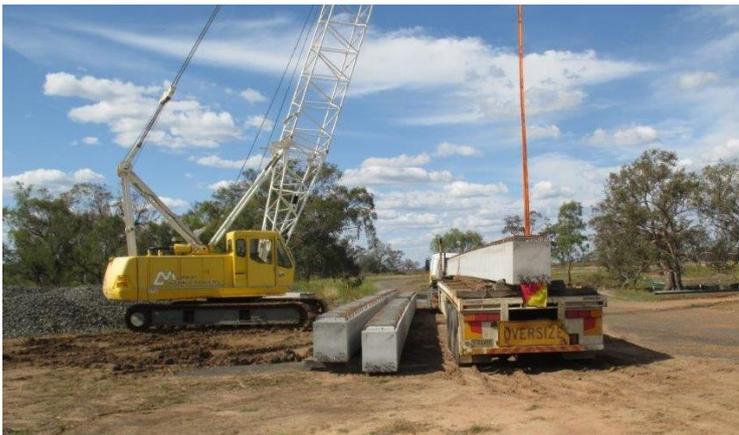
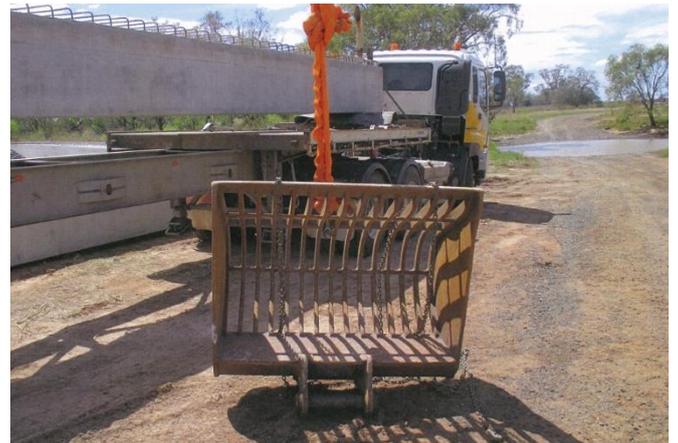
A 70-year-old truck driver was fatally crushed while unloading a 400-500kg excavator sieve bucket from a semi-trailer. The bucket was lashed to the semi-trailer. When the chains holding the bucket were released, the bucket slid and toppled off the truck, crushing the worker between the bucket and a bridge beam on the ground next to the truck.

Site where the incident took place and the bucket involved in the incident.

- check that the load has not shifted during transportation before releasing the transportation restraints
- develop and document a Safe Work Method Statement (SWMS), in consultation with your workers, for unloading plant and equipment with a crane. Make sure all relevant workers understand and implement the SWMS.
- where necessary, sling the load to lifting equipment, such as a crane, prior to releasing the transportation restraints

- determine the weight or centre of gravity of the load, and the slinging technique to be used. A Dogging High Risk Licence is required for this type of work
- establish exclusion zones to make sure people are not placed within potential fall zones
