SAFETY ALERT

INCIDENT	Working inside of Safety Lateral Zone (A1/P2)
SUBJECT	Critical Risk – Traffic – Always work to an approved Traffic Management Plan
INCIDENT DATE	12-12-2019
BUSINESS UNIT	Higgins - MacKay's to Peka Peka (M2PP)

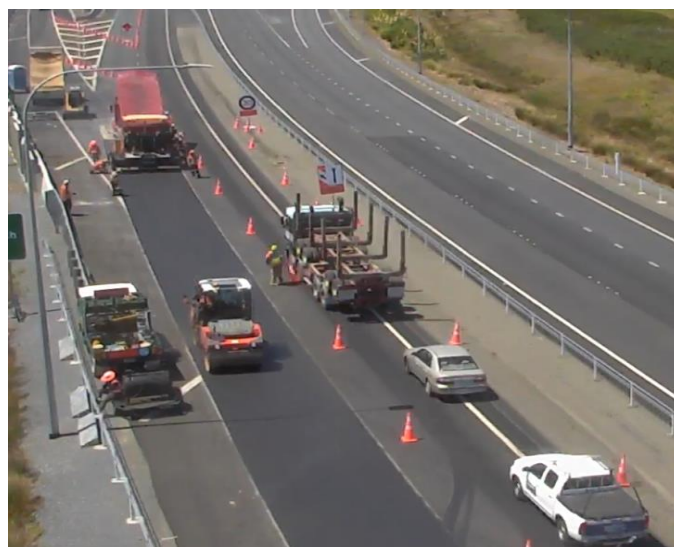
While standing inside the lateral safety zone, the STMS has reported that a logging truck travelling through the site has struck his Stop/Slow Paddle but camera footage discounts this. It does show the truck hit a misaligned cone near the STMS, likely due to the driver trying to avoid a temporary sign to his right that is leaning heavily into the lane.

The video also showed the paving staff working in the lateral safety zone. This safety zone should give 1m clearance to live traffic from the work zone, with no staff or machinery working or being parked inside it. No workers were seen in the live lane.

- Pending the results of the incident investigation, it appears that Insufficient working room has been allowed for workers, as well as keeping a 1 metre Safety Lateral Zone as required in the TMP.
- The STMS has stood in the lateral safety zone while operating stop/go paddle
- Misaligned cone and temporary sign have reduced temporary lane width for heavy traffic.

- Risk Assessment to be reviewed and re-written with specific reference to the hazards outlined in the traffic management plan, specifically the implementation & enforcement of the safety lateral zone.
- Recommendation to staff to place a second cone line to demarcate the Lateral Zone for easier ID.
- Incident debriefed with affected staff and reminder of paving and safety zone widths (as overleaf)
