LA 016	Auxiliary line stowage bracket broke off piling rig	10.7.2020
---------------	--	------------------

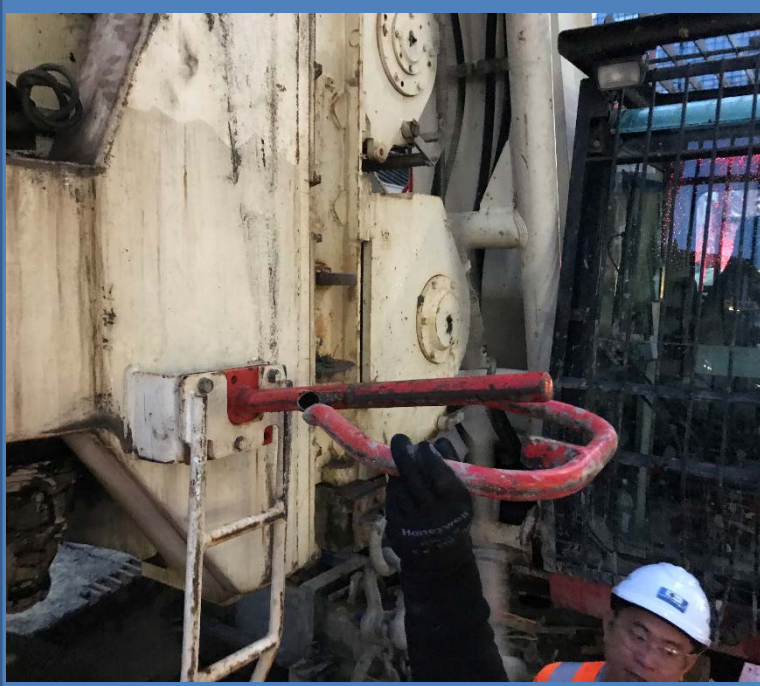
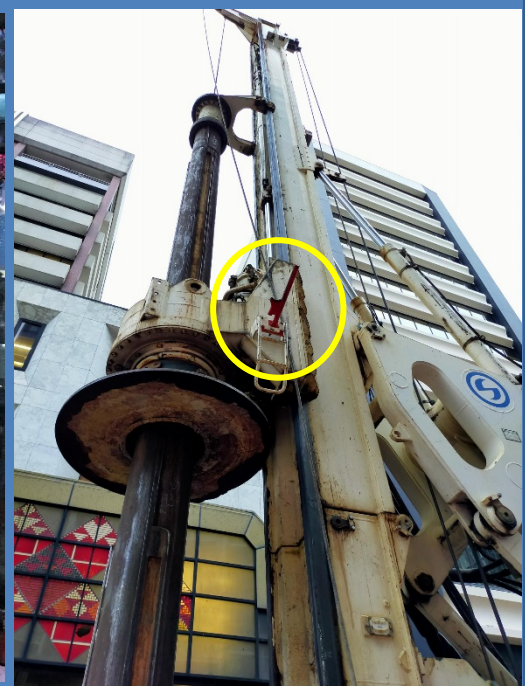
WHAT HAPPENED?	<p>At 2.59 pm Monday 6th July. The Piling crew attached the Rigs auxiliary line to a casing and started to lift it with the line still secured behind the stowage bracket located on the rotary head of the rig. The Banksman would normally release the line from behind the bracket before it's attached to any load, this was overlooked in this instance.</p> <p>As the auxiliary rope came under tension to lift the casing the rope pulled the bracket off the rig sending it flying through the air 5 metres above ground level and dropped onto the site boundary fencing and then dropped into the public footpath. Fortunately No one was on the footpath.</p> <p>The Bracket weighs approx.1.5kg and is 300mm x 400 mm x 25 mm.</p>
-----------------------	---

2	Could this happen on your job? What can you do to prevent it?
	<ul style="list-style-type: none"> • Change the configuration of the auxiliary stowage with an alternative engineered solution. • Maintain suitable exclusion zones around plant to protect workers from falling objects. • Erect Mesh netting (or similar) above hoarding to protect public walkways.
3	Where can you get extra information and support?
	<ul style="list-style-type: none"> • Link Alliance Health and Safety Team • Industry guidance from the piling federation of Australia regarding auxiliary lines. • SBI Exclusion Zones around Heavy Plant & Equipment Guidelines and Best Practices
