Track Press Cylinder Failure

Mines safety alert no. 371

Mine Type: Coal Mine - Surface

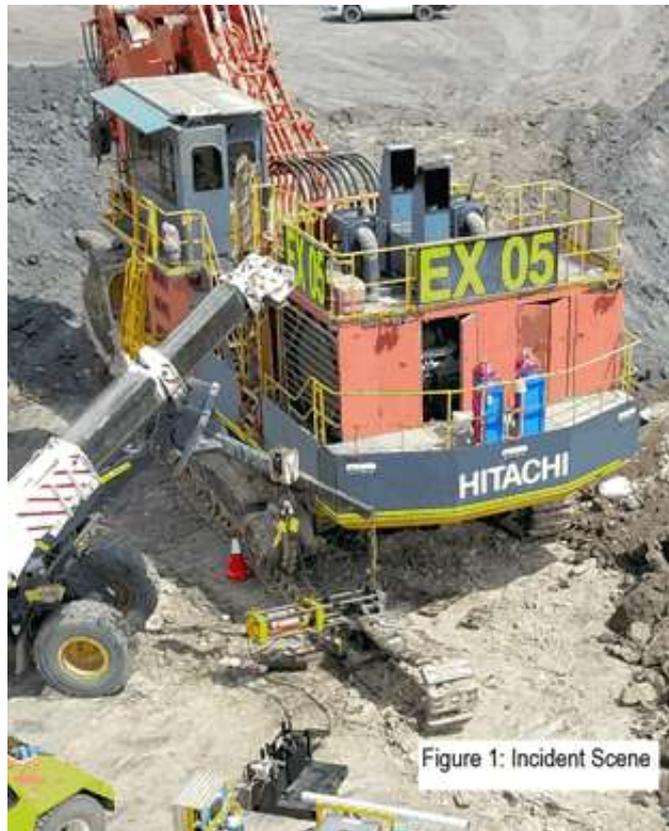
A serious accident occurred whilst coal mine workers (CMWs) were undertaking track repairs on a Hitachi EX1900 excavator at a mine site (refer Figure 1). The workers were preparing to use a 360 tonne track press. Whilst aligning the track press in preparation to press out a track pin the pressurised cylinder head plate failed catastrophically.

The failed component struck a worker causing serious arm injuries. He was airlifted to a Brisbane hospital and has required multiple operations and ongoing rehabilitation.

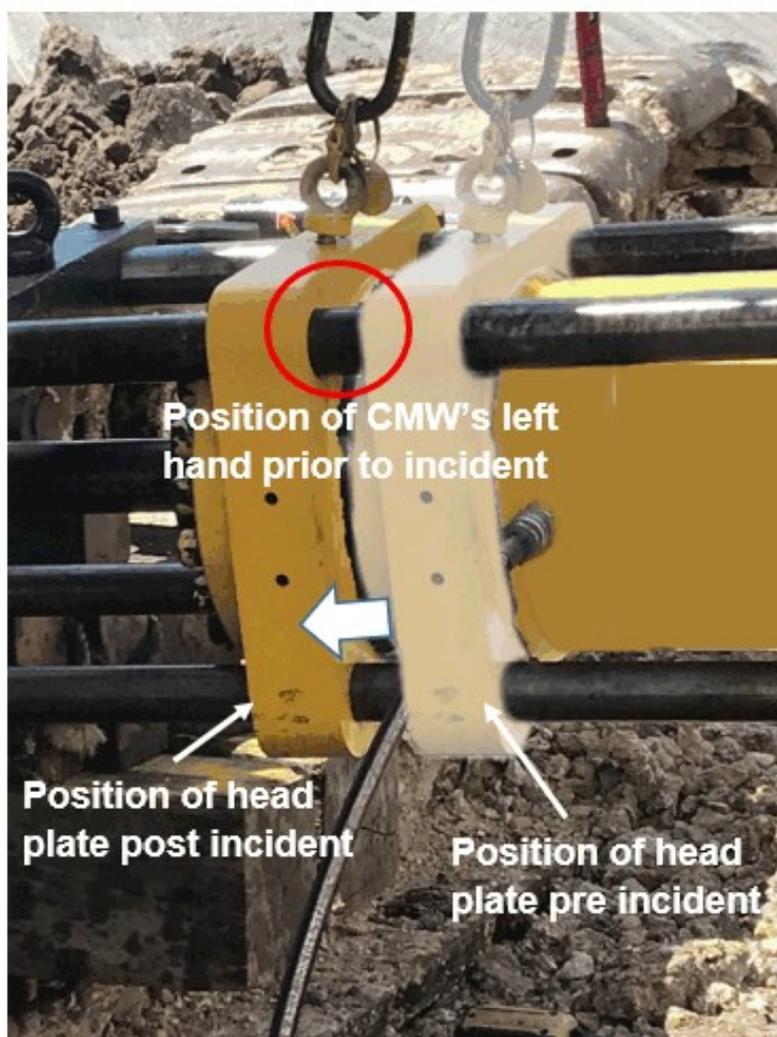
- Evidence of historic repeated occurrences of cylinder hydraulic pressure intensification.
- The head plate separated from the cylinder at the head plate weld. Repeated occurrences of pressure intensification in the rod end chamber i.e. overloading, initially caused cylinder distortion and ultimately head plate weld separation (refer Figure 2).

- Restricted oil flow from the rod end chamber, during normal pressing operations, created pressure intensification in a portion of the cylinder that is not supposed to experience high pressure.

- Poor internal engineering design of the cylinder resulted in pressure intensification.
- Poorly functioning hydraulic fittings (quick connect couplings) on the return hose restricted the oil flow, creating the high pressure condition in the rod end chamber.

- Inadequate deactivation of the quick connect check valves during operation resulted in a blocked hydraulic return line.
- Lack of appropriate pressure controls to prevent over-pressure events.

No pressure control system was present in the piston or rod end chamber to control pressure intensification. Such a device could have reduced the rod end chamber pressure from the pump unit, and eliminated the intensification.

Mine sites should have a robust system for inspection of equipment used for maintaining plant as per S79 of the CMSHR.

- An inspection process for equipment used for maintaining plant to ensure the equipment meets site requirements and standards. This should include all tooling used by contractors that bring Electrical, Hydraulic and Pneumatic tooling to site.
- An effective Contractor Management System that includes ensuring Supervisors understand their responsibilities.
- A robust Risk Assessment (RA) process restricting the use of pre-populated and ranked Job Safe Analysis (JSA) or similar documents.

- Suppliers of equipment and services to the mining industry must review and ensure all similar track press units and associated pumps, hosing and fittings are operational and not compromised.
- Suppliers of equipment and services to the mining industry must ensure they have a robust testing and maintenance program to ensure all defects are identified and rectified prior to supplying equipment.
