LA 0020	Oxy-Acetylene set caught under counterweight of a crane	16.11.20
----------------	--	-----------------

Safety Alert

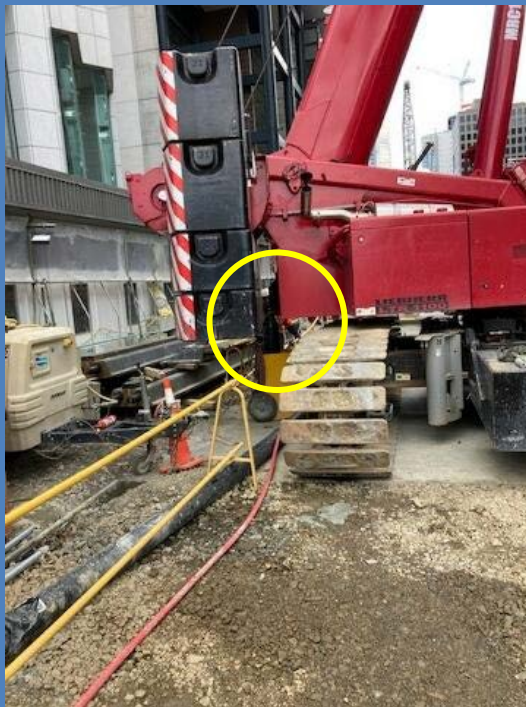
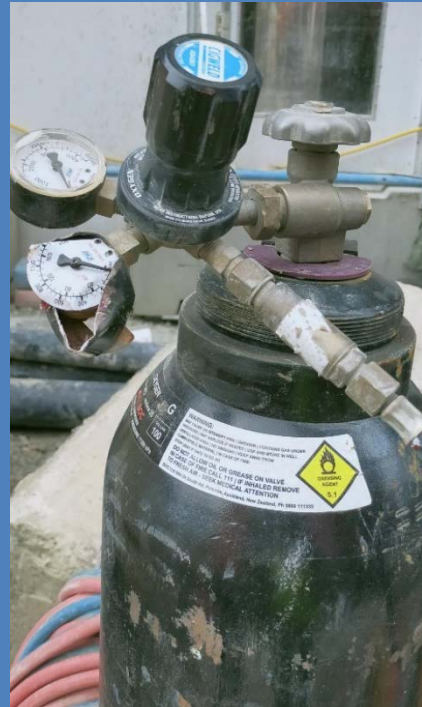
WHAT HAPPENED?	<p>Oxy-acetylene set on a trolley was left out on site from the previous days' works.</p> <p>When a 100t crane was re-positioned into the area, the team failed to identify the oxy-acetylene set situated 0.5m from the tracks of the crane.</p> <p>When the crane slewed, the oxy-acetylene set got caught in-between the counterweight and the tracks. This resulted in damage to the oxygen gauge. This was noticed by a worker in another area who raised the alarm with the crane crew.</p>
-----------------------	---

- Crane movements to be planned and inspected before the crane is positioned in a new work area;
- All crane movements to have a suitable number of spotters assigned.
- Restricted zones around cranes & walkways to be established before works commencing.
- Gas bottles to have a designated safe area for storage when not in use.
- All Gas bottle & trolleys on-site to be reviewed for a safer alternative.
