SHE ALERT

SHE H175 A 2020
Issued by: Kier Highway SHE
Department
Date: 17/11/2020

Office Units Demobilisation Injury

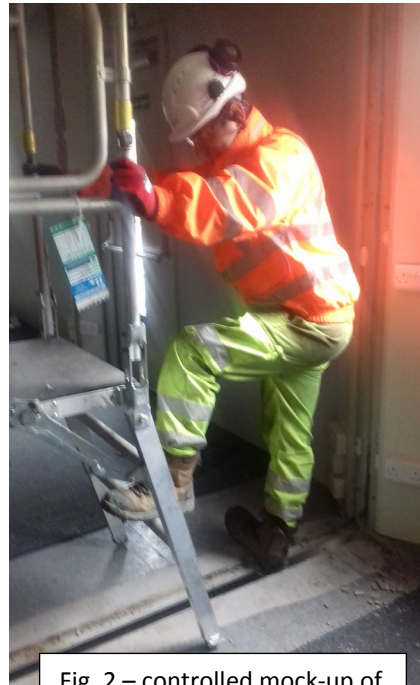
Fig. 2 – controlled mock-up of how the incident occurred.

- A ceiling trim was overlooked during the removal of the internal trim.
- A review of the Safe Systems of Work it was found that there was a lack of planning & sequencing of works documented within the contractors RAMS referring to the internal strip out process of the modular buildings.
- The work zone where the former main office site had been handed over to the contractor to control during the decommissioning.

- Contractor review and revise their Safe System of Work detailing the sequence of works.
- Floor trims to remain in place until all ceiling work is completed.
- Supervisors to check work phases are completed fully before moving onto next.
- WAH Platforms should be placed away from any gaps or trip hazards.
