INVESTIGATION INFORMATION RELEASE

Worker's arm injured in belt press filter

Incident date: 17 May 2020.

Location: Moolarben Coal Operations – Coal Handling and Processing Plant ('the CHPP')

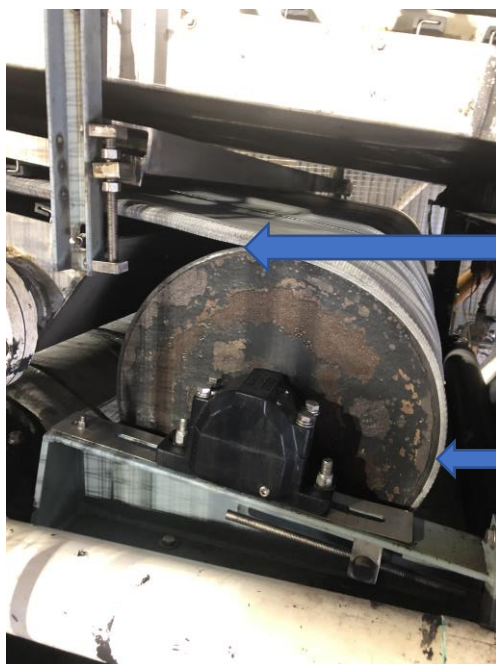
Figure 1 – Location of belt press filter where the worker's arm became caught

Point of entanglement

Approximate location of worker's arm when
the emergency stop was activated.

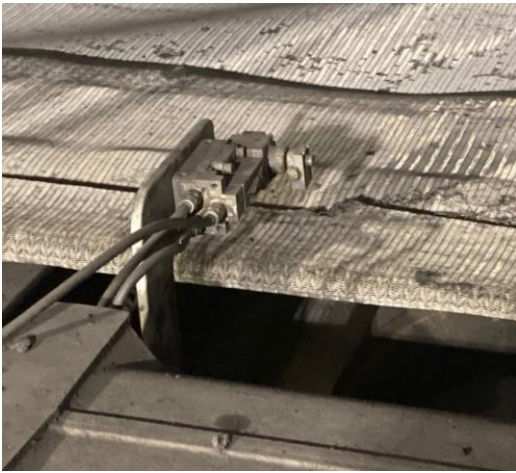
The worker restored air pressure to the above components. He believed that the tracking drum would straighten the misaligned belt as it rotated. However, the tracking limit switch on the filter was designed to stop the plant from operating when a metal prong referred to as a 'cats' whisker' contacted a misaligned belt. In order to override this function and allow the tracking drum to continue to turn and align the belt, the worker removed the 'cat's whisker' by disconnecting it from the limit switch.

Figure 2 – Filter 3 with cat's whisker removed

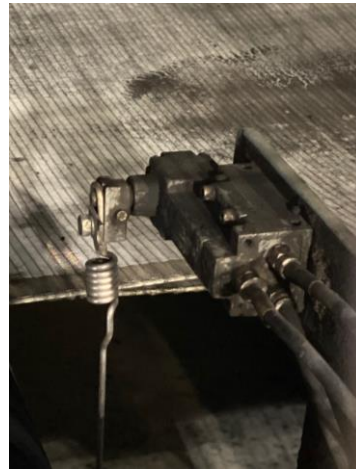
Figure 3 – Adjacent filter with cat's whisker fitted

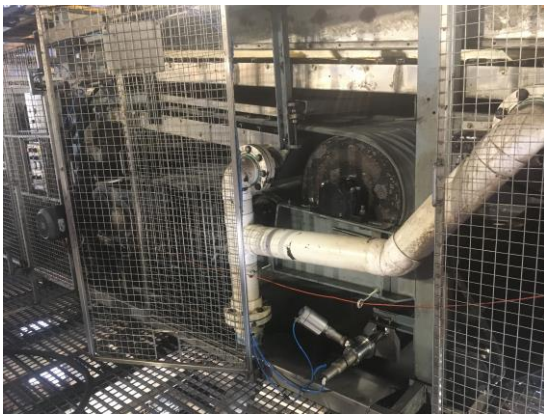
The worker was moving towards a rotating drum located in an area where the guarding had been opened. He stated that he lost balance and reached out to what he thought was part of a fixed structure adjacent to the drum. His left forearm was caught between the belt and the rotating drum. The drum had rotated approximately 135 degrees, when the supervisor arrived in response to the worker's earlier radio message. The supervisor and another staff member activated the filter's emergency stop and reversed the drum to release the worker's arm.

Figure 4 – Proximity of filter to the open guard door

Mine operators and workers must ensure that when guarding around plant is removed for maintenance or cleaning purposes, all energy sources are isolated. Consideration must be given to installing interlock

devices that prevent unguarded plant from operating when risks are present. Guarding must be restored to its secured position before the plant resumes operation.
